# Cambrian School District Facilities Needs Assessment & Master Plan

February 2021

*Facilities Needs Assessment & Master Plan 2021*

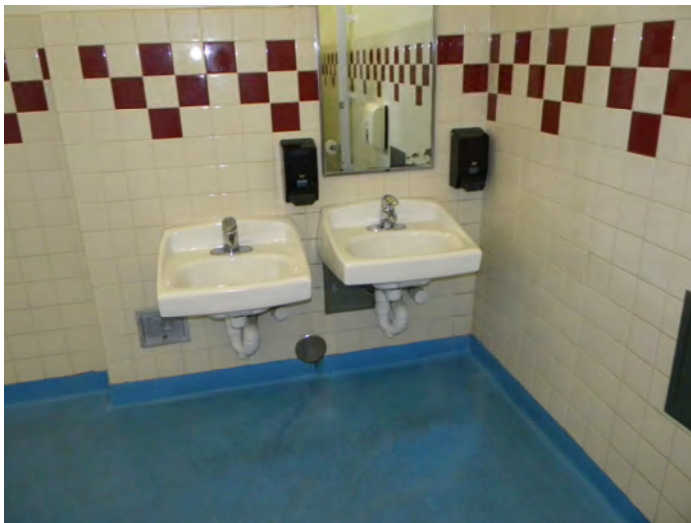
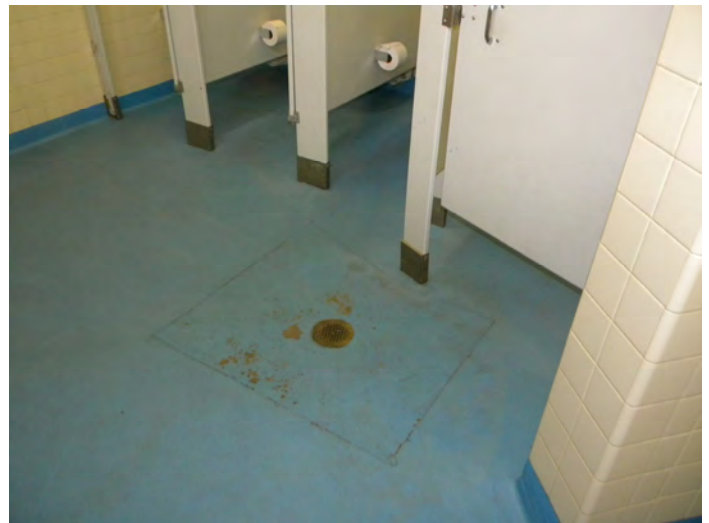
## 26. Restrooms/Partitions/Fixtures

The existing bathrooms were renovated in 2003. There are a few small bathrooms that were not updated. The modernized bathrooms are in fair condition but will likely need to be upgraded in the next ten years. The bathroom floors are in poor condition

and will need to be upgraded in the next five years. The faucets are older and should be replaced. There are a select few fixtures that need to be replaced.

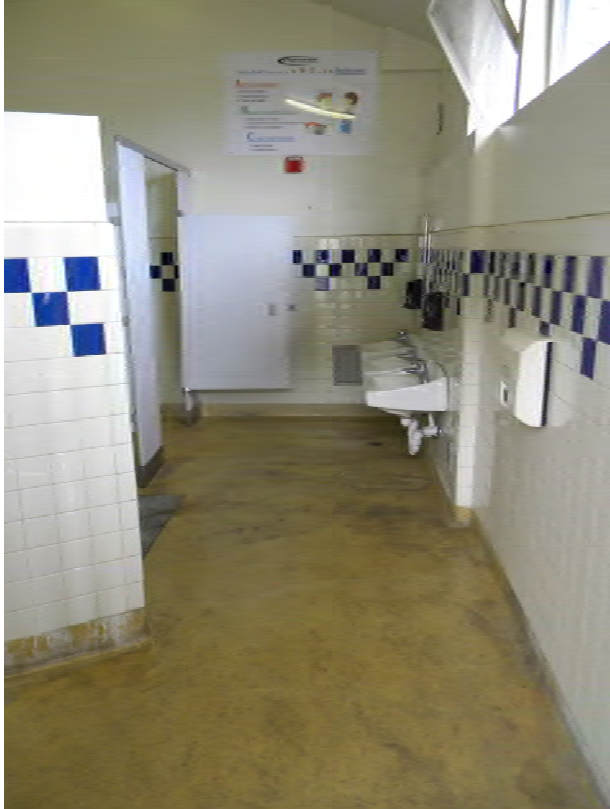
## 26. Restrooms/Partitions/Fixtures

The existing bathrooms were renovated in 2003. There are a few small bathrooms that were not updated. The modernized bathrooms are in fair condition but will likely need to be upgraded in the next ten years. The bathrooms floors are in poor condition and will need to be upgraded in the next five years. The faucets are older and should be replaced. There are a select few fixtures that need to be replaced.

It is recommended that the bathroom floors be upgraded in the next five years. Toilet partitions should all be replaced in the next ten years. It would be desirable to replace all facets and flushometers with the District Standard touchless devices.

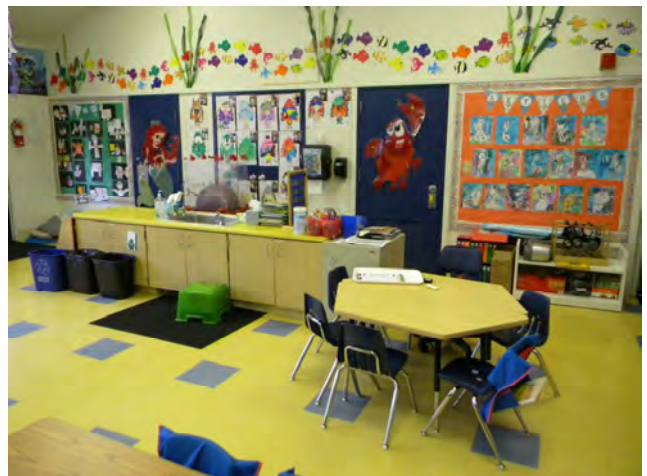
The vaulted ceilings were designed without proper ventilation in the cavity of the ceiling system. When AC was added to the classrooms, condensations at the peak of the vault and beam began to show and drip, especially when the outside temperature greatly differed from the inside temperature.

The best solution would be to remove all roofing and ceilings stripping all finishes down to the roof structure, adding new ventilation in all blocking and allowing cavities to properly vent to a continuous roof vent. Unfortunately, the ideal solution is cost prohibitive. Another solution would be to create a new sealed flat ceiling system in each classroom creating a new attic space above that can buffer between the conditioned space and the outside.

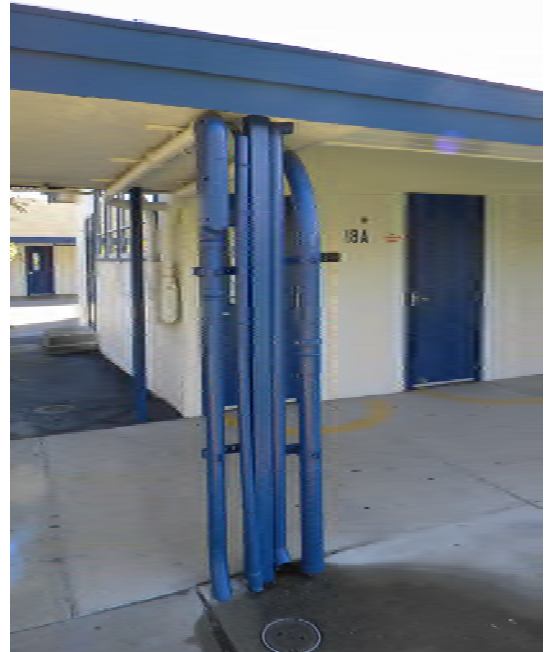
Some of the underground utilities supplying gas and water to the site are over 40 years in age. Some of the underground water was replaced. The existing sewer system is composed of an antiquated clay piping system which allows tree roots to grip and break existing underground piping. These underground utilities have surpassed their intended service life. Replacing the underground utilities will drastically reduce the need for ongoing maintenance of these systems. Past modernizations and electrical upgrade routed new heavy electrical conduits on eaves, roofs and columns. The campus was not intended nor designed for these heavy conduits that blemish the campus. It has been reported that this campus may need additional seismic gas shut offs. Domestic backflow preventor is on need of replacement.

It is recommended that all existing underground utilities older than 40 years be replaced with new utility systems. Underground water, storm, sewer and gas lines should all be replaced entirely at this site. It is recommended that all existing electrical conduits be removed from the eaves, roofs and columns throughout the campus and rerouted underground. The cost estimate will assume some additional seismic gas shut offs be added to this campus. The domestic water backflow is recommended to be replaced.

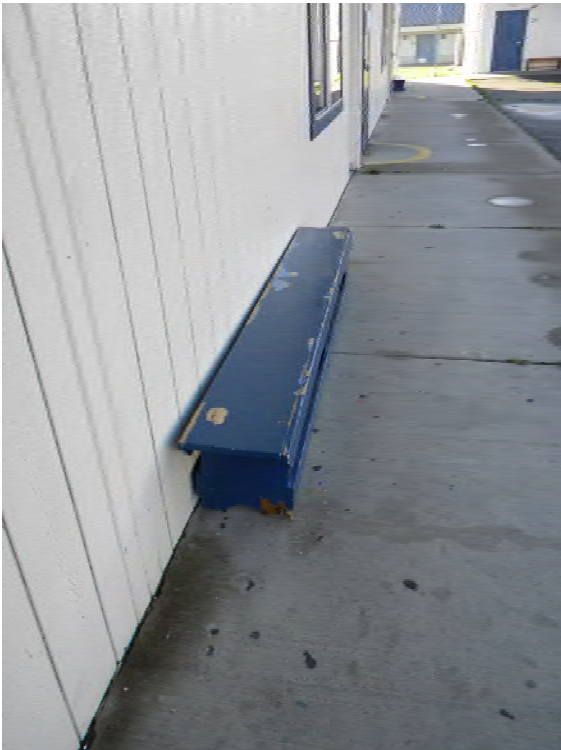
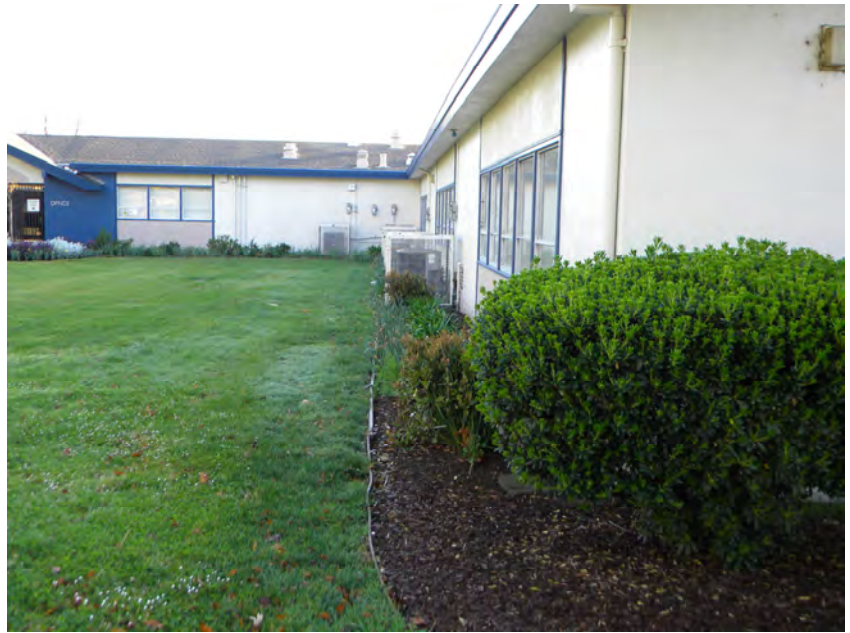
The existing concrete walkway system appears to handle foot traffic well at the site; however, several areas of the existing walkways have cracks and other signs of deterioration. There have been several trenching

projects whereas the concrete has a lot of patching.

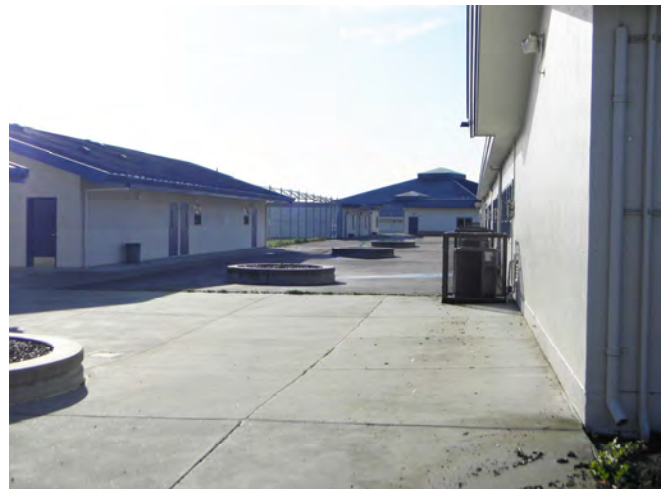
Based on the roofing report, all roofing is in good condition. It was noted that some of the drains are clogged with debris and need ongoing maintenance. It was also noted that some blistering occurred in between the layers of felt and roofing membranes. Some UV damage has occurred in the perimeter flashing at the shingle roofing area.

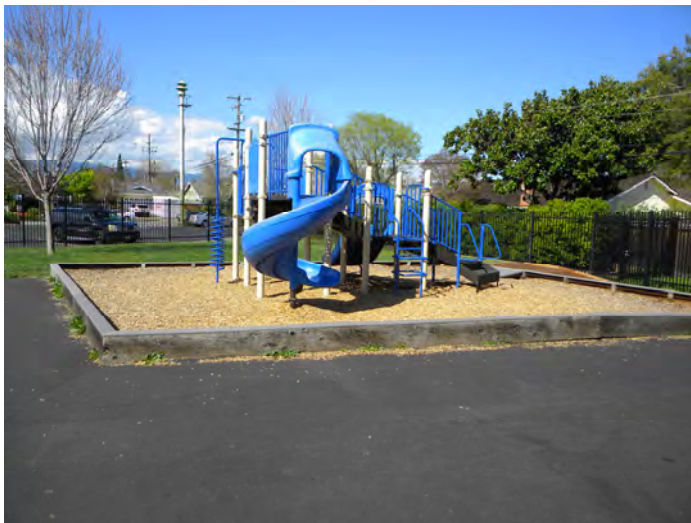
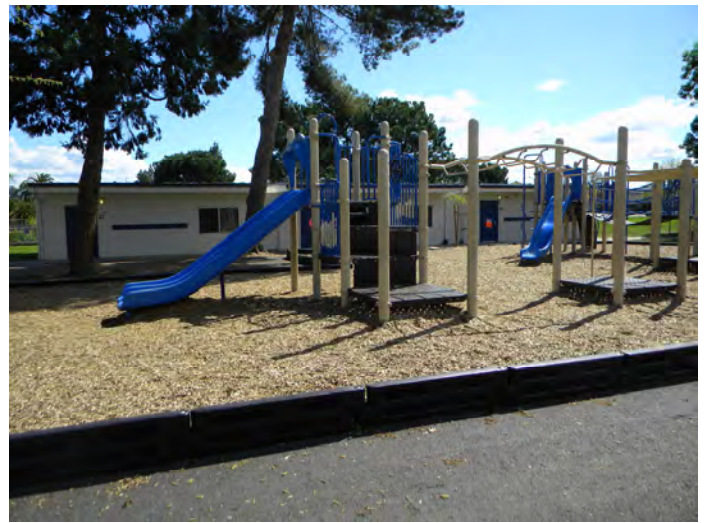
This kindergarten and the general play structures are in fair condition. The fall zone is composed of wood chip loose material which has to be replenished as the existing fiber material gets kicked out, compacted, and

floats away. The perimeter of the play structure fall material is raised and not designed to meet the intent of accessibility.

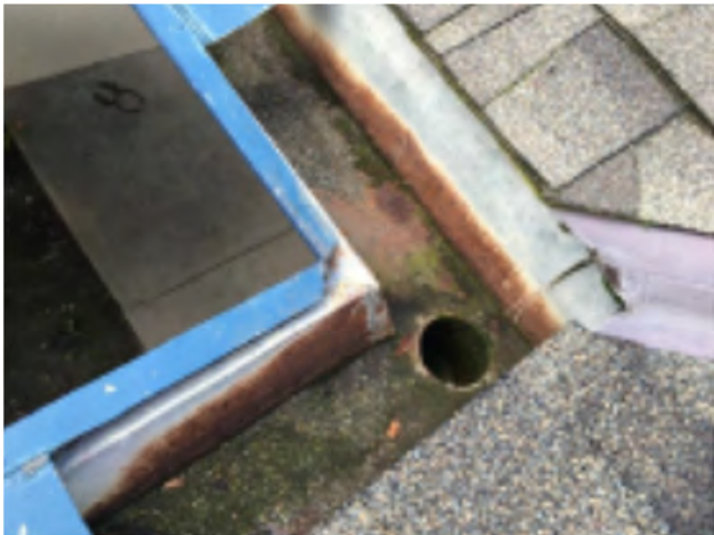
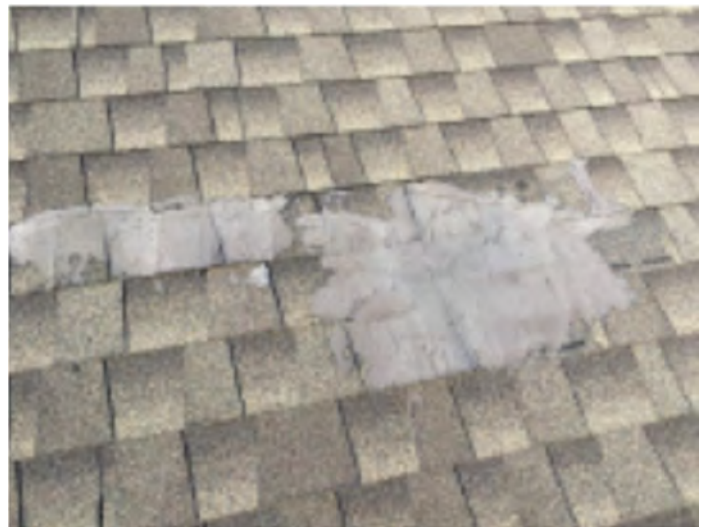
## 22. Roofing

Based on the roofing report, all roofing is in good condition as it was reportedly installed in 2006. It was noted that leaves and debris have filled some gutters. The shingle roofs are in good condition, however, there are some damaged or missing shingles that should be replaced. A metal chimney cap is rusted. Portable classroom #18 has had recent leaks. It was noted that there were rusted gutters that need to be monitored.

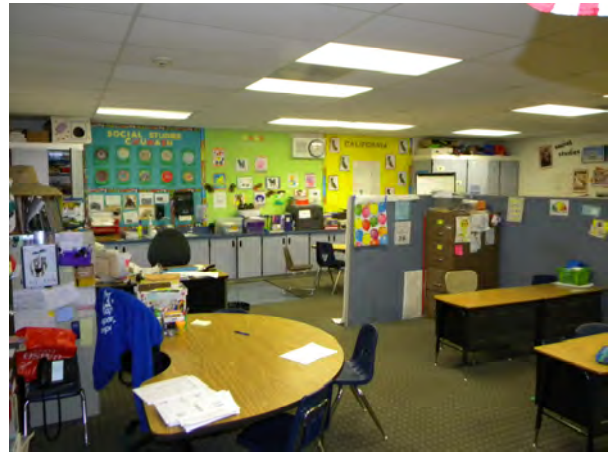
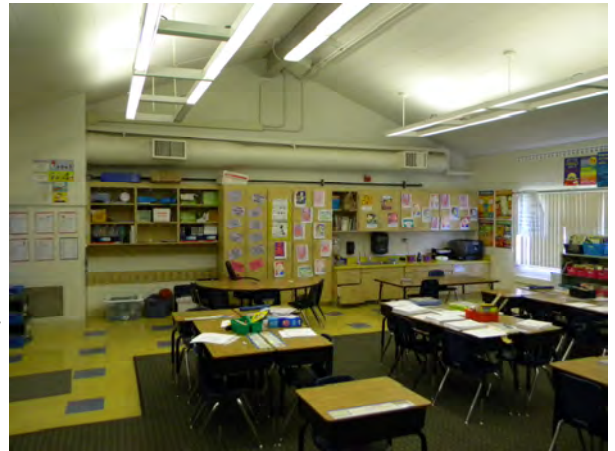
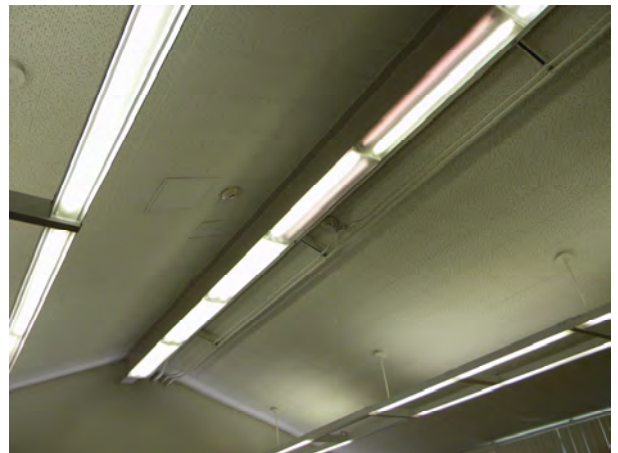
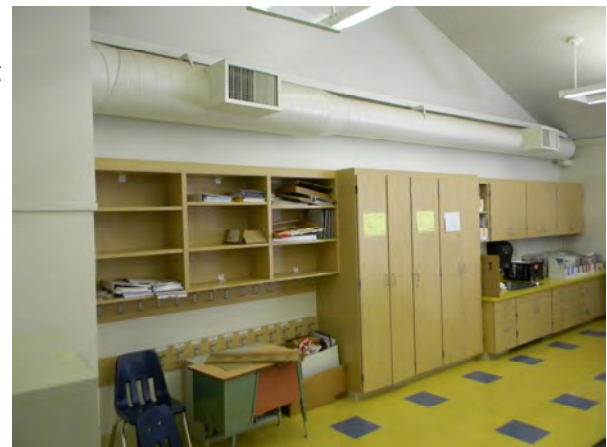
The existing HVAC system has been replaced at the entire campus during the 2003 modernization. HVAC units lifecycle is fifteen years. These HVAC units are now fifteen years old. The EMS is constantly requiring maintenance and needs to be upgraded.

It is recommended that all HVAC systems and the EMS system at this entire campus be replaced in the next five years.
