# Cambrian School District Facilities Needs Assessment & Master Plan

February 2021

*Facilities Needs Assessment & Master Plan 2021*

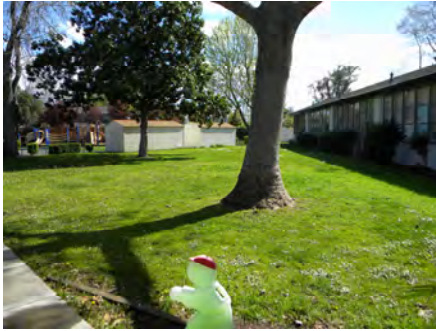
## 6. Landscaping and Irrigation

This campus has a large amount of mature trees located at various locations throughout this campus which require ongoing trimming. Landscaping is in fair condition. The District would like to upgrade landscaping with drought tolerant native plants that require less water. Irrigation controls and valves are in need of replacement.

It is recommended that all mature trees be trimmed as required and that all plantings be replaced with drought tolerant natives. All valves and irrigation controls should be replaced.

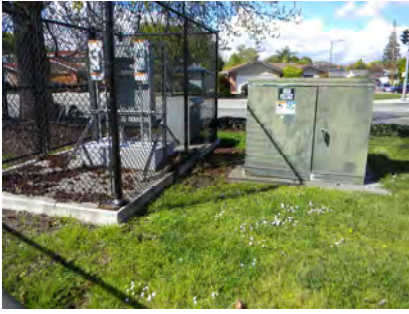
Past modernizations and electrical upgrade routed new heavy electrical conduits on eaves, roofs and columns. The campus was not intended nor designed for these heavy conduits that blemish the campus. It has been reported that this campus may need additional seismic gas shut offs. The domestic backflow preventor is in need of replacement.

It is recommended that all existing underground utilities older than 40 years be replaced with new utility systems. Underground water, storm, sewer and gas lines should all be replaced entirely at this site. It is recommended that all existing electrical conduits be removed from the eaves, roofs and columns throughout the campus and rerouted underground. The cost estimate will assume some additional seismic gas shut offs be added to this campus. The domestic water backflow is recommended to be replaced.

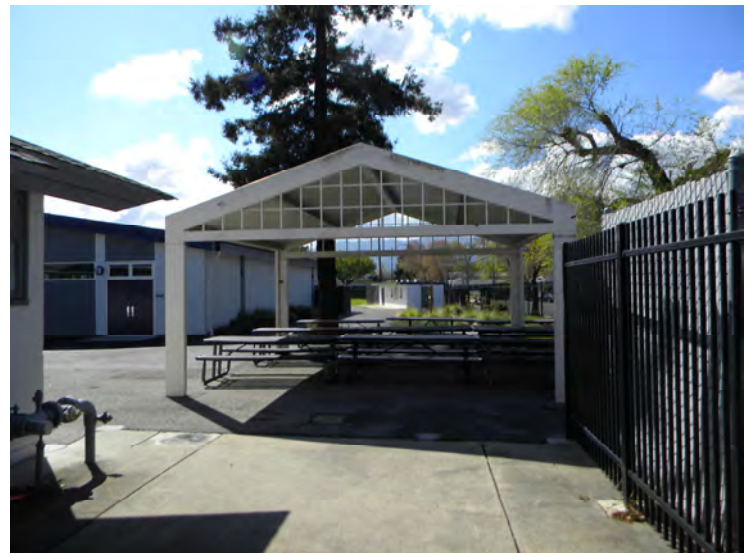
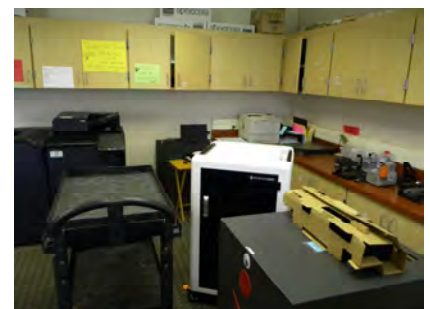
A preliminary structural review of this campus was performed to determine if any structural upgrades might be necessary. Preliminary studies indicate that all buildings are seismically sufficient..

It is recommended that a more detailed structural analysis be performed to determine the extent of voluntary structural upgrades that should be

incorporated into the next phase of modernization for any building that is modernized.

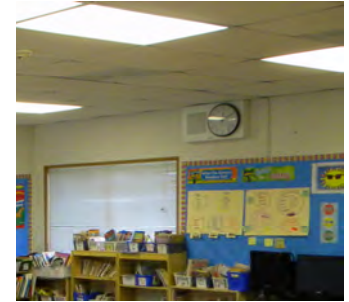
### 50. STEAM Lab

There is not a dedicated contemporary space used in the manner of a STEAM lab.

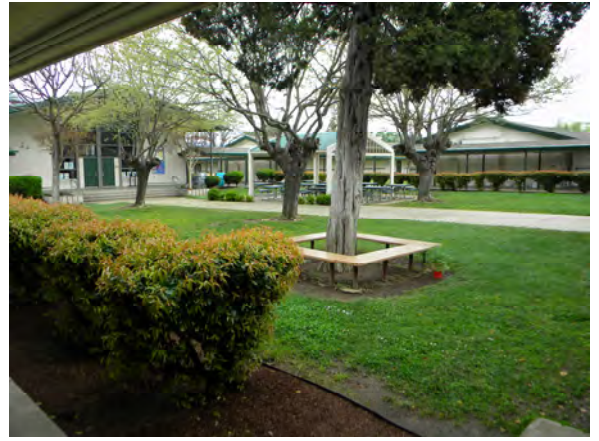
## 2. Site ADA Compliance

There are locations where pavement has heaved or cracked in the ADA path of travel. Some concrete walkways should be widened or removed and replaced.

It is recommended that several portions of existing walkways in the ADA path of travel be repaired and new concrete walkways be widened and/or added.

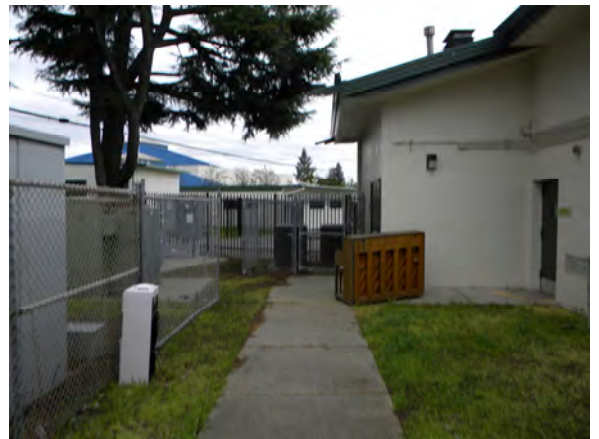
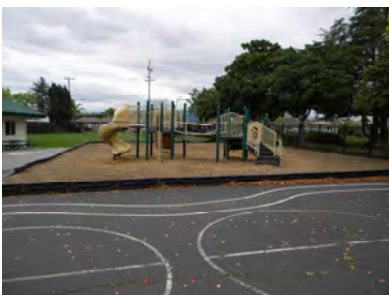
## 4. Paved Play Area

The paved play area at Fammatre Elementary is in fair condition however there are several cracks in the pavement that need to be repaired.

It is recommended that the existing play area be overlaid with new AC pavement and slurry sealed with new striping.

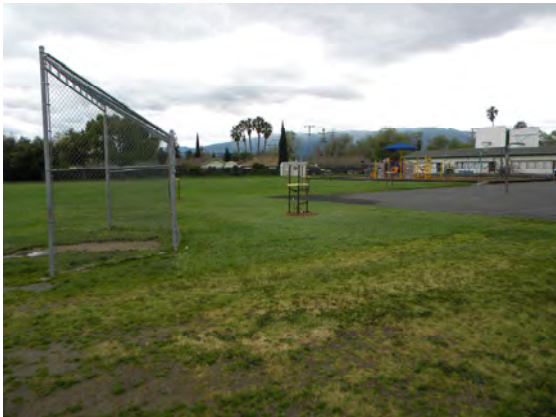
6. Landscaping and Irrigation

This campus has a large amount of mature trees and shrubbery located at various locations throughout this campus which require ongoing trimming. Landscaping is in fair condition. The District would like to upgrade landscaping with drought tolerant native plants that require less water. Irrigation controls and valves are in need of replacement.

It is recommended that all mature trees be trimmed as required and that all plantings be replaced with drought tolerant natives. All valves and irrigation controls should be replaced.

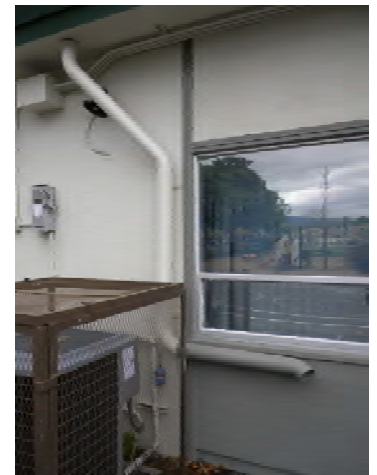
Exterior lighting is not ideal for nighttime security. The District maintenance is difficult as the pole lighting is very high.

It is recommended that pole lights and roof mounted lighting be replaced with new LED lighting at the parking lot and throughout the campus.

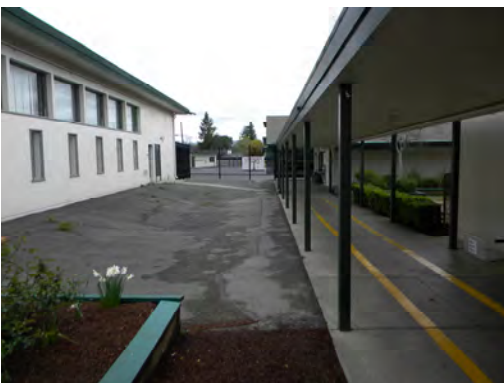
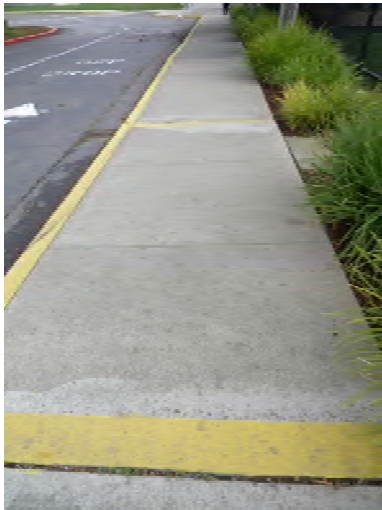
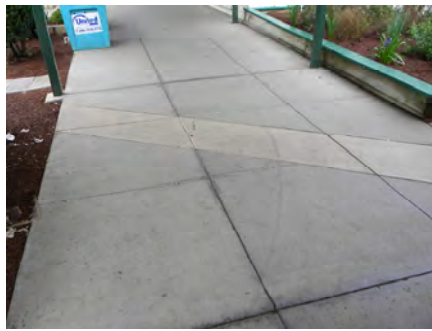
## 13. Concrete Walkways

The existing concrete walkway system appears to handle foot traffic well at the site; however, several areas of the existing walkways have cracks and other signs of deterioration. There have been several trenching projects whereas the concrete has a lot of patching. There is a new concrete walk needed at the front of the campus at the large grass area as pedestrians are currently using a desired line pathway on dirt. There are existing concrete walkways that need to be widened or added at egress locations.

It is recommended that large cracked areas of the walkways be replaced to the nearest expansion joint. It is also recommended that entire walkways are removed where patching has occurred in the past. New concrete walkways should be added for additional egress.

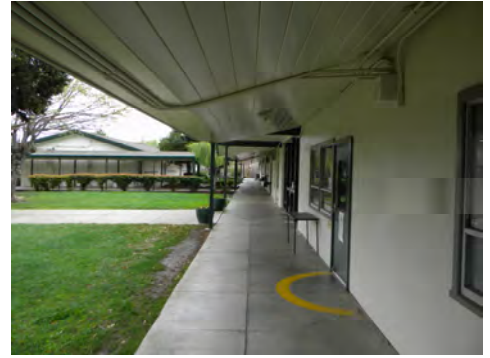
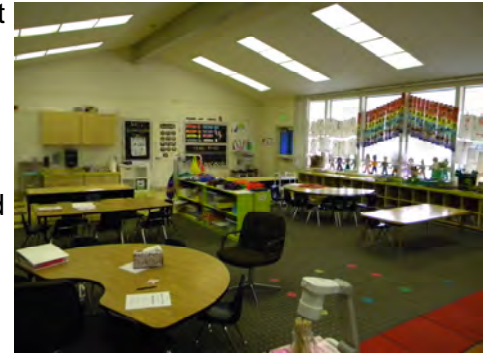
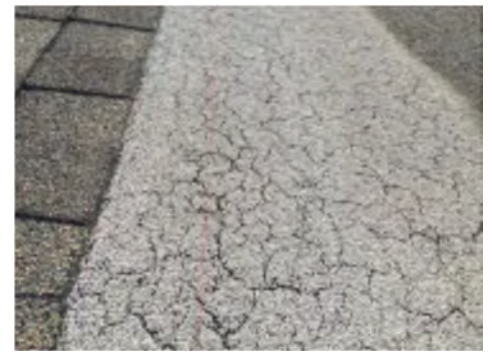
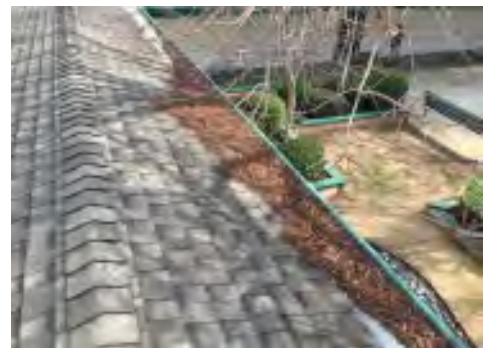
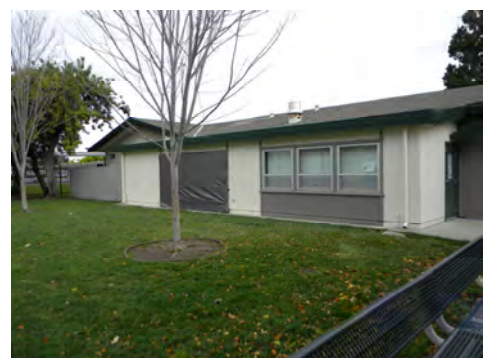
## 24. Building Insulation and Windows

The original campus buildings were constructed in an era when natural resources such as natural gas and electricity were inexpensive. Windows are single glazed throughout and insulation does not currently meet new construction standards. The window blinds have are older and need to be replaced. The newer Modular classroom building

adjacent to the Kindergarten wing has double glazing and will not need to be upgraded.

It is recommended that insulation be added to all exterior walls, except the newer classroom wing, and added to all ceiling cavities. Windows should be replaced with double glazed window systems retrofitted with new window blinds at all campus buildings except the newer classroom wing.

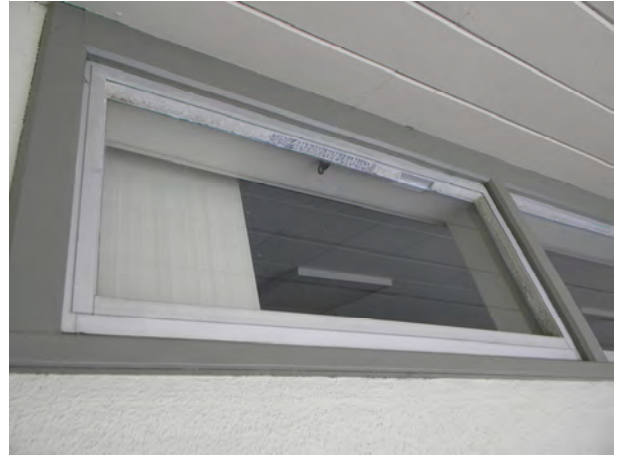
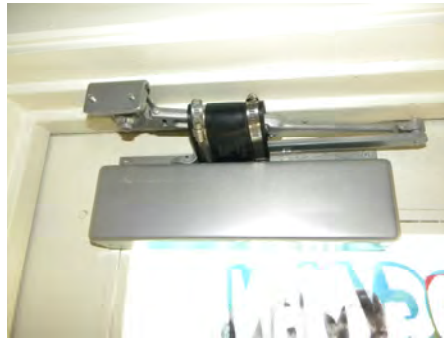
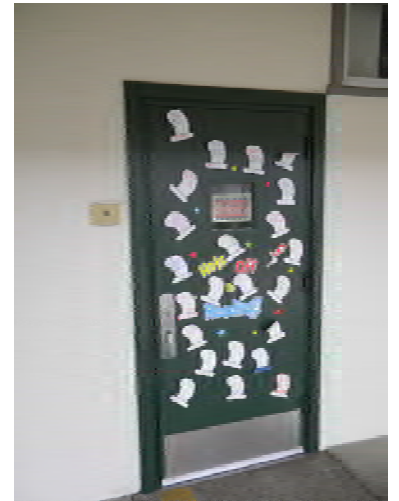
The campus hardware and doors are in good condition, however the existing locking system does not currently meet the District's requirements for appropriate security. There are some doors that will need to be replaced due to heavy usage and damage over the years.

It is recommended that all hardware be replaced with District Standard secure hardware throughout this campus. It is assumed that several existing doors will need to be replaced to make appropriate alterations for the new hardware installation. The cost estimate will make an assumption for the number of replacements needed.

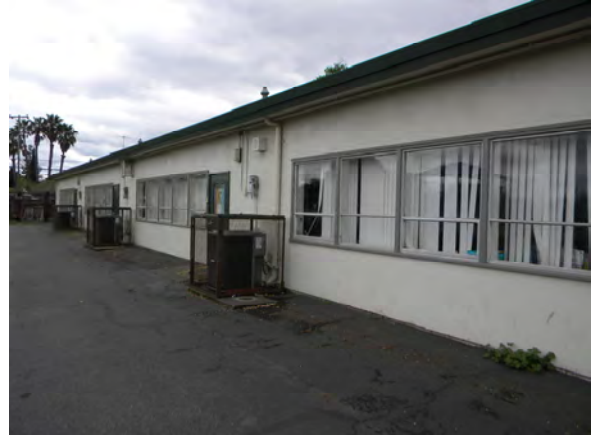
### 33. Heating Ventilating and Air Conditioning

The existing HVAC system has been replaced at the entire campus during the 2005 modernization. HVAC units lifecycle is fifteen years. These HVAC units are now fifteen years old. The EMS is constantly requiring maintenance and needs to be upgraded.

It is recommended that all HVAC systems and the EMS system at this entire campus be replaced in the next five years.

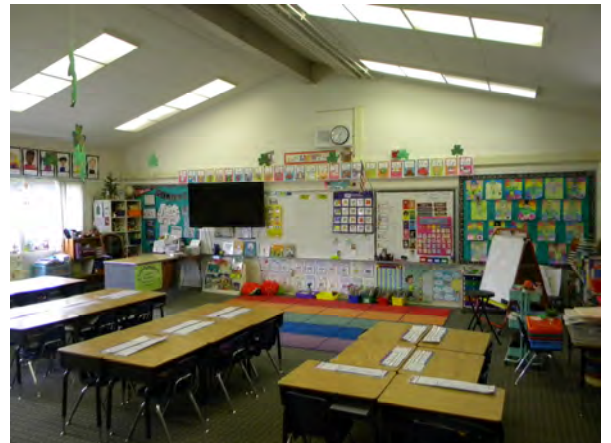
### 34. Interior Lighting

The existing fluorescent lighting throughout this campus is adequate, however, it is highly desirable to retrofit all classrooms with new LED technology to allow for additional electrical efficiency while allowing for the new option of dimming lights on demand.

It is recommended that all classrooms be retrofitted with new LED lights throughout the campus with new dimmable switching.

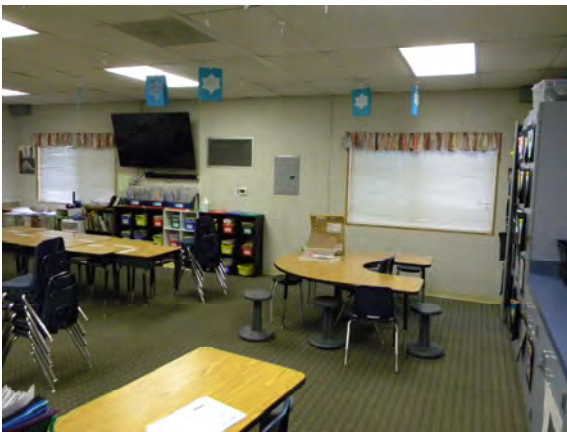
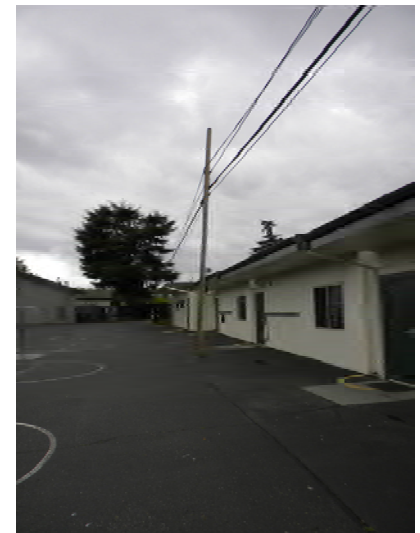
### 40. Alteration of Existing Portable Buildings

There is a cluster of four portable classrooms that are in fair condition at the northwest portion of the campus as they are over twenty years old.

There are no known reasons for upgrades to the portable classrooms at this time. Refer to Sections 41 and 53 for replacement of portables.

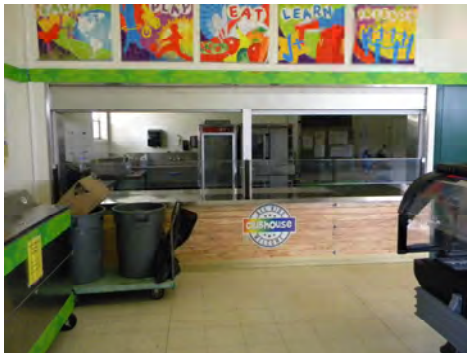
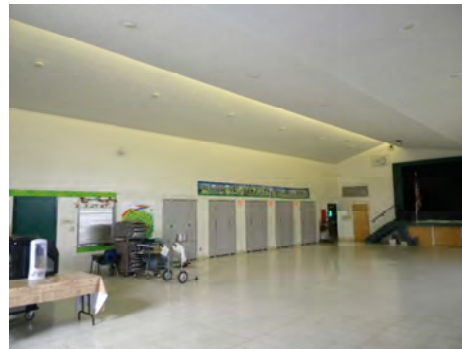
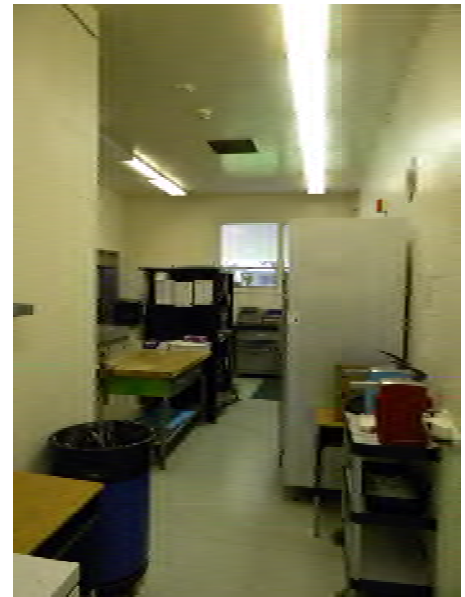
44. Cafeteria/Kitchen/Gymnasium/Music/ Wrestling Rooms

The cafeteria space is adequate but the finishes should be upgraded. The kitchen is older and is in need of renovation with new equipment.

It is recommended that the cafeteria be upgraded with new finishes. The kitchen should be renovated with new kitchen equipment.

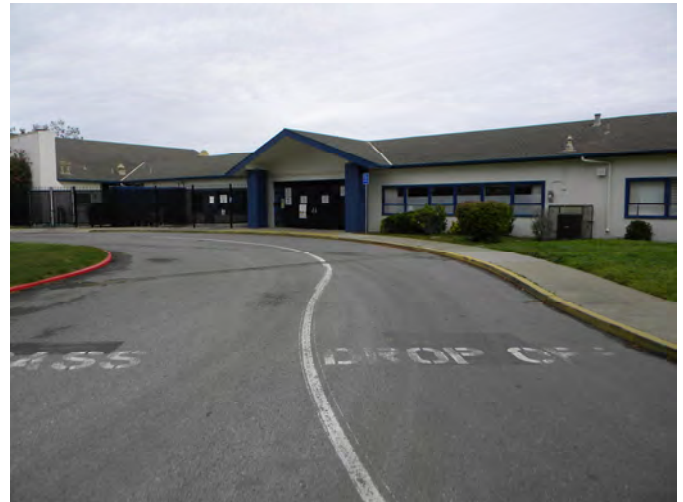
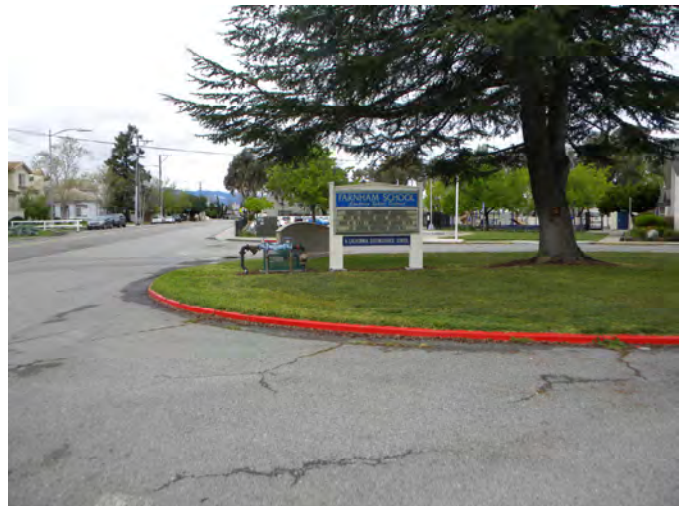
The existing parking size and configuration at Farnham hasn't changed significantly in the last thirty years. The flow of traffic inefficiently designed with a separate buss drop off area that exists adjacent to the entrance of the main parking lot. The condition of the pavement is in fair condition. The existing parking lot could be expanded and altered to be significantly more efficient.

It is recommended that the parking lot be altered and expanded combining the bus drop off area with the existing parking lot. The parking lot should be designed to have a dedicated drop off area for the parents that would allow them to pass as needed after dropping off or picking up their children. The existing parking area should be resurfaced with a new slurry seal and striping.

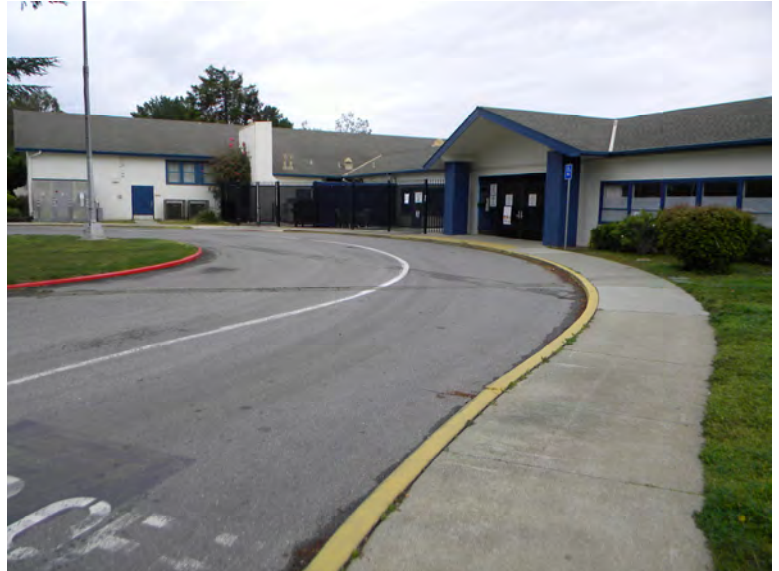
Some flatwork and walkways were upgraded in previous modernizations. There are locations where pavement has heaved or cracked in the ADA path of travel.

It is recommended that several portions of existing walkways in the ADA path of travel be repaired.

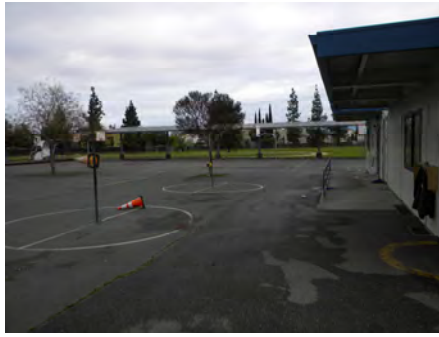
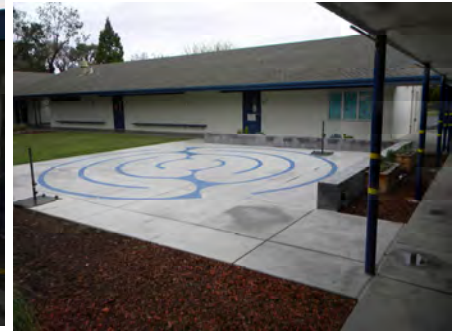
This campus has a large amount of mature trees located at various locations throughout this campus which require ongoing trimming. Landscaping is in fair condition. The District would like to upgrade landscaping with drought tolerant native plants that require less water. Irrigation controls and valves are in need of replacement.

It is recommended that all mature trees be trimmed as required and that all plantings be replaced with drought tolerant natives. All valves and irrigation controls should be replaced.

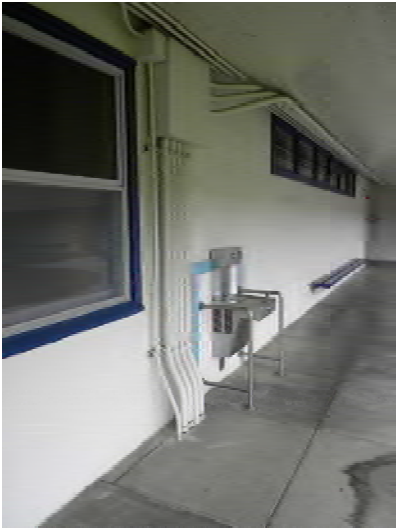
Some of the underground utilities supplying gas to the site are over 40 years in age. The water lines were replaced to this campus except underground water under the kitchen. The existing sewer system is composed of an antiquated clay piping system which allows tree roots to grip and break existing underground piping. These underground utilities have surpassed their intended service life. Replacing the underground utilities will drastically reduce the need for ongoing maintenance of these systems. Past modernizations and electrical upgrade routed new heavy electrical conduits on eaves, roofs, at the underside of vaulted ceilings

and columns. The campus was not intended nor designed for these heavy conduits that blemish the campus. It has been reported that this campus may need additional seismic gas shut offs. Domestic backflow preventor is on need of replacement.

It is recommended that all existing underground utilities older than 40 years be replaced with new utility systems. Underground storm, sewer and gas lines and the water lines under the kitchen should all be replaced at this site. It is recommended that all existing electrical conduits be removed from the eaves, roofs and columns throughout the campus and rerouted underground. The cost estimate will assume some additional seismic gas shut offs be added to this campus. The domestic water backflow is recommended to be replaced.

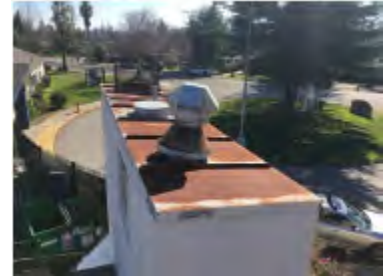
Based on the roofing report, all roofing is in good condition as it was reportedly installed in 2005. It was noted that leaves and debris have filled some gutters. The shingle roofs are in good condition, however, there are some damaged or missing shingles that should be replaced. A metal chimney cap is rusted. Portable classroom #18 has had recent leaks.

It is recommended maintenance toward cleaning roofs free of leaves and debris and replacing several damaged or missing shingles selectively throughout this campus. It is also recommend to restore Portable #18 metal roof and the rusted chimney roof.

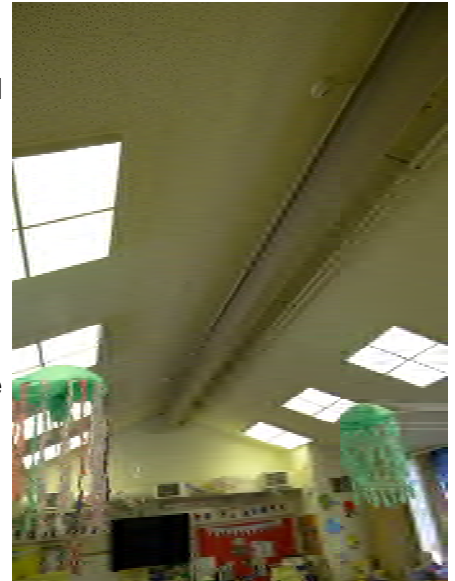
The best solution would be to remove all roofing and ceilings stripping all finishes down to the roof structure, adding new ventilation in all blocking and allowing cavities to properly vent to a continuous roof vent. Unfortunately, the ideal solution is cost prohibitive. Another solution would be to create a new sealed flat ceiling system in each classroom creating a new attic space above that can buffer between the conditioned space and the outside.

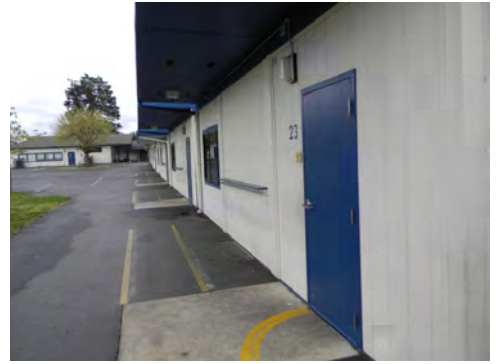
Since the opening of Steindorf school, overpopulation at this school has settled whereas additional portable classrooms are not needed. The existing portable classrooms at the southeastern portion of the campus are have outlasted their intended Lifecycle and are extremely old and should be replaced and relocated to a new location.

It is recommended that the existing old portable buildings at the southeast portion of the campus be removed from the campus. If necessary, a new permanent classroom building should be constructed elsewhere on this campus.

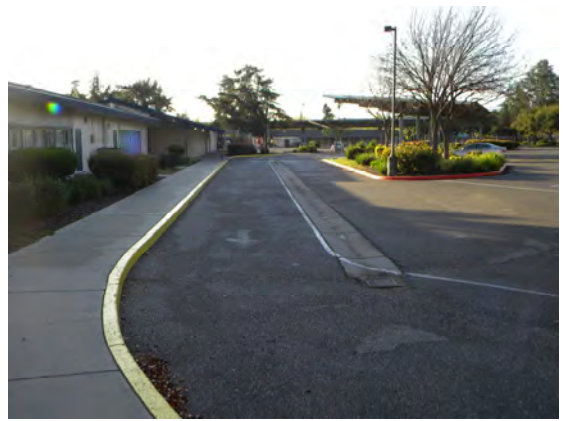
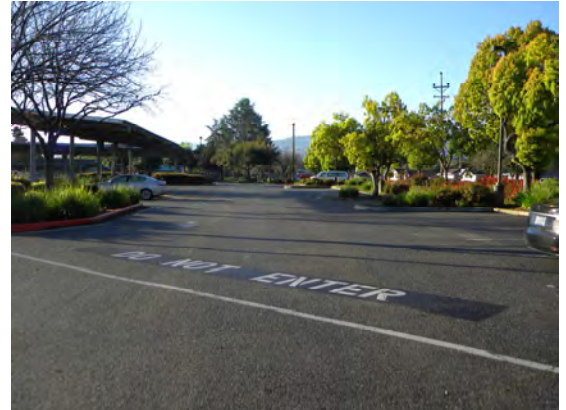
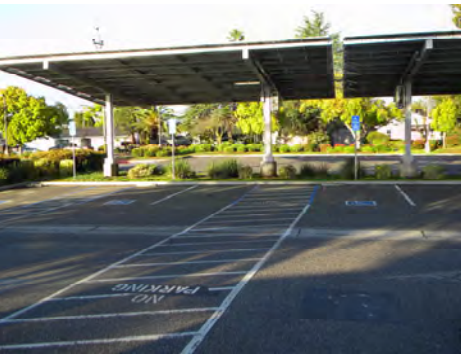
The existing parking size and configuration at Price Charter hasn't changed significantly in the last thirty years. The flow of traffic is awkward and confusing. The apparent design layout was to stack parent drop off in a manner as to avoid backup into the street. The condition of the pavement is in good condition. There is not much available area to expand or modify the existing parking area at the front of the school.

It is recommended that the parking lot be maintained with overlay and slurry with striping in the next five to seven years.

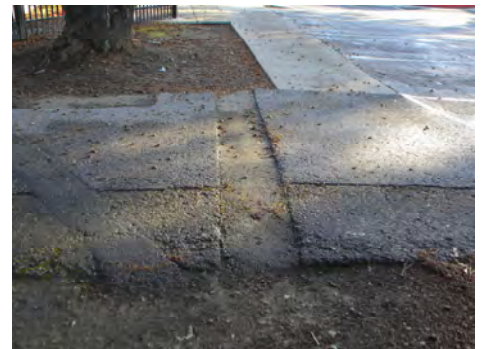
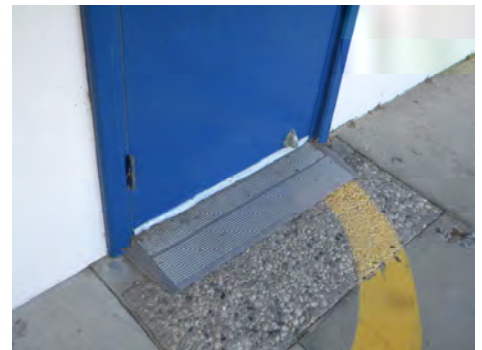
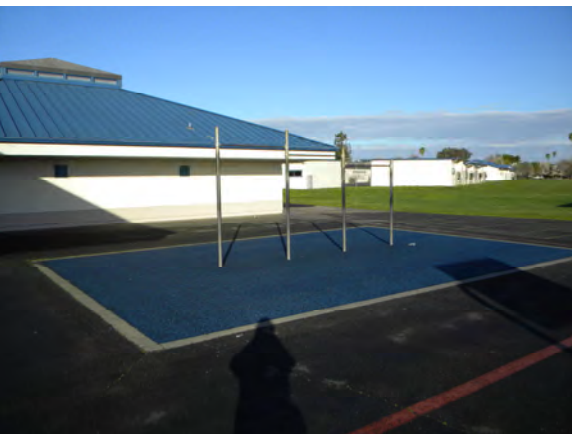
Some flatwork and walkways were upgraded in previous modernizations. Most of the classrooms were modified to allow for flush entry by grading the inside of the classrooms during the 2004 and 2005 modernizations. Several classrooms have metal ramps that complied with code at that time fifteen years ago and are "grandfathered" in. There are locations where pavement has heaved or cracked in the ADA path of travel.

It is recommended that several concrete walkways be removed and replaced with ADA compliant level concrete walkways. A new concrete walk will need to replace the existing concrete walkway along the existing doorways where existing metal ramps are currently installed.

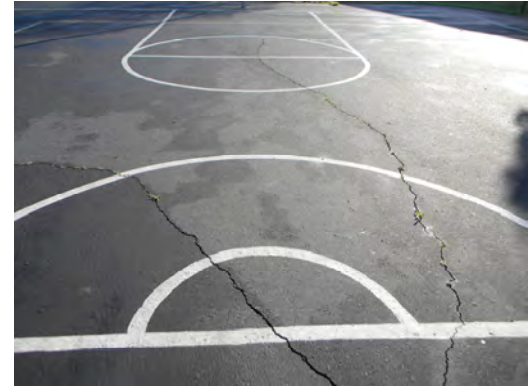
The paved play area at Ida Price is in fair condition however there are several cracks in the pavement that need to be repaired.

It is recommended that the existing play area and courtyard be overlaid with new AC pavement and slurry sealed with new striping.

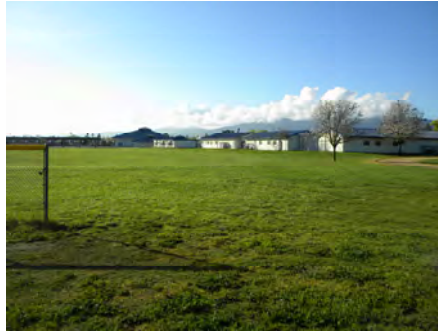
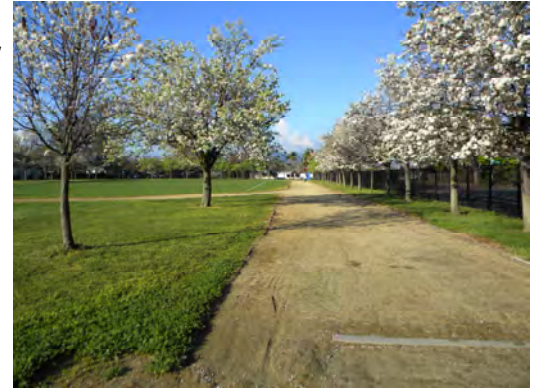
This campus has a sophisticated based ball field and snack bar and a large turf area with a decomposed granite track. The existing track is uneven and is in need of ongoing maintenance. The existing turf is in fair condition but has some uneven surfaces and requires a large amount of maintenance. Many of the planter areas are in need of new ground covering.

It is recommended that the track be replaced with a new synthetic track with synthetic grass. New fiber and ground covering should be added to the existing planting area.

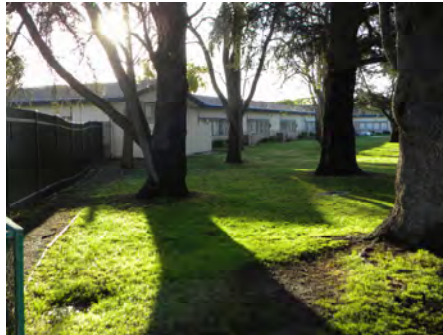
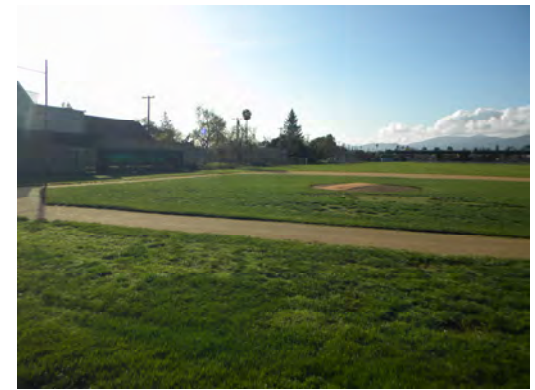
This campus has a large amount of mature trees located at various locations throughout this campus which require ongoing trimming. Landscaping is in fair condition. The District would like to upgrade landscaping with drought tolerant native plants that require less water. Irrigation controls and valves are in need of replacement.

It is recommended that all mature trees be trimmed as required and that all plantings be replaced with drought tolerant natives. All valves and irrigation controls should be replaced.

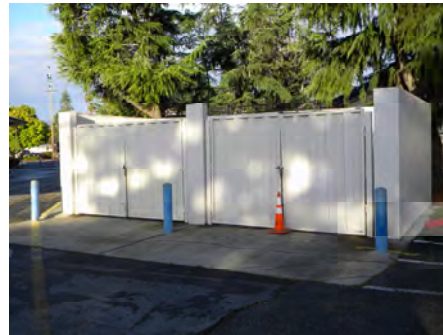
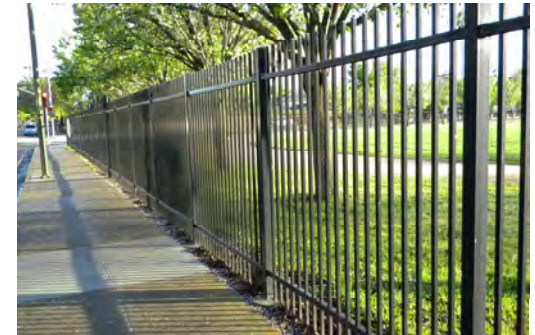
New decorative fencing was added at the perimeter of the entire campus in 2014. The campus was modified to secure or lock down the campus in the event of an undesirable situation.

There is no known reason for additional fencing and security at this campus.

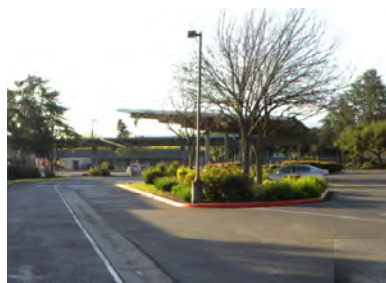
This site has adequate electrical service to this site.

There is no need for additional electrical upgrades to the service.

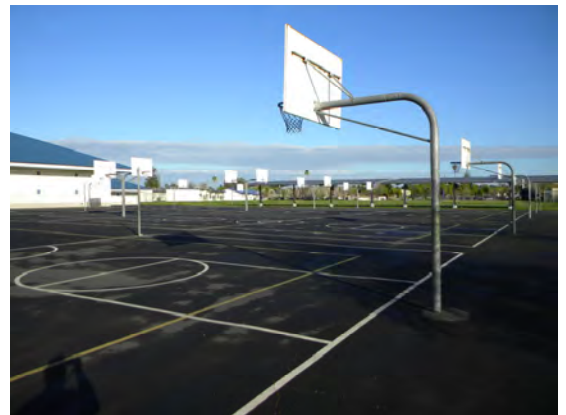
Exterior lighting is not ideal for nighttime security. The District maintenance is difficult as the pole lighting is very high.

It is recommended that pole lights and roof mounted lighting be replaced with new LED lighting at the parking lot and throughout the campus.

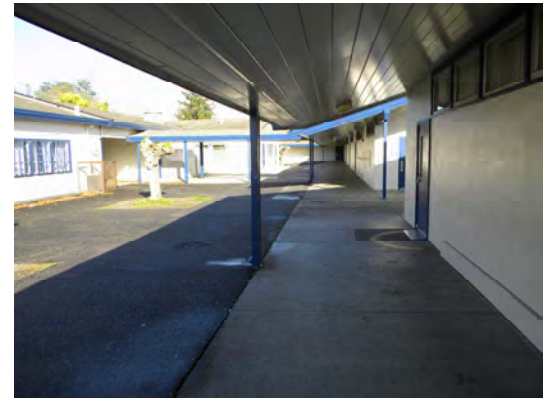
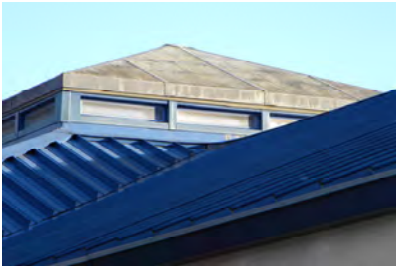
Based on the roofing report, all roofing is in good condition. It was noted that some of the drains are clogged with debris and need ongoing maintenance. It was also noted that some blistering occurred in between the layers of felt and roofing membranes. Some UV damage has occurred in the perimeter flashing at the shingle roofing area.

It is recommended that repairs and maintenance be made at the classroom wings and kitchen roof including clean roofs free of leaves and debris, adding 3 course repair to blisters and BUR penetration seams. It is also recommend to coat the expansion cap covers, restore the deteriorating BUR perimeter and replace missing drain screens.

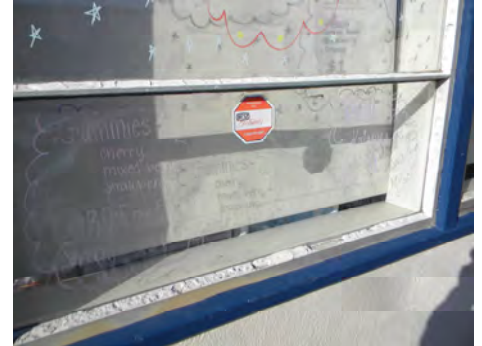
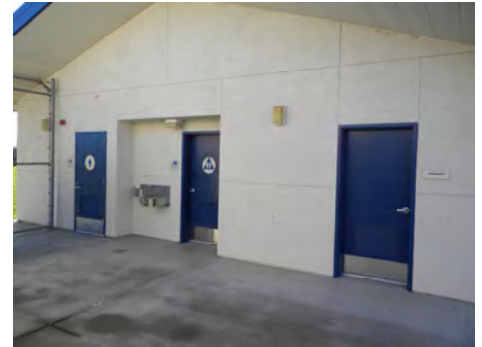
The original campus buildings were constructed in an era when natural resources such as natural gas and electricity were inexpensive. Windows are single glazed throughout and insulation does not currently meet new construction standards. The window blinds have are older and need to be replaced. The skylights in the Gymnasium have exceeded their intended life. The existing thickened lamination system is discolored and decaying. The walls and windows for the gymnasium and the science buildings are newer and do not need to be upgraded.

It is recommended that insulation be added to all exterior walls and added to all ceiling cavities. Windows should be replaced with double glazed window systems retrofitted with new window blinds. It is recommended that the skylight system in the Gymnasium be replaced with a new system.

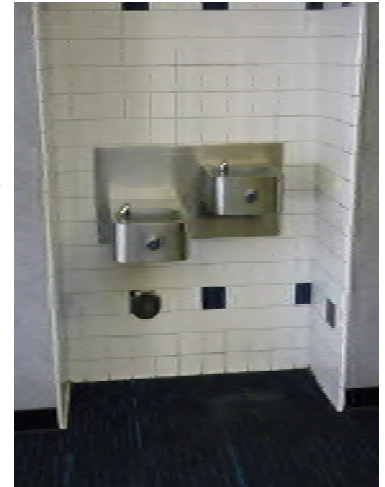
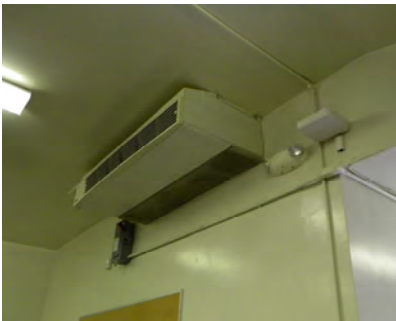
The existing HVAC system has been replaced at the entire campus during the 2005 modernization. There are no known issue at this time related to the existing systems at this campus. HVAC units lifecycle is fifteen years. These HVAC units are now fifteen years old. The EMS is constantly requiring maintenance and needs to be upgraded.

It is recommended that all HVAC systems and the EMS system at this entire campus, except the heat pump units in the Science Classrooms, be replaced in the next five years.

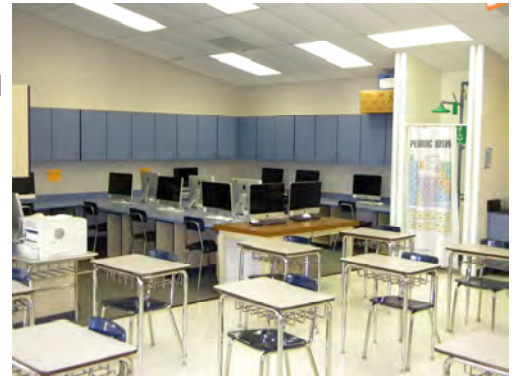
## 50. STEAM Lab

There is not a dedicated contemporary space used in the manner of a STEAM lab.

As recommended in the Computer Lab/Art section above, the existing Industrial Art and Art rooms should be converted to STEAM labs with flexible uses and flexible furnishings. Refer to Section 48 in the cost estimate for this recommendation.

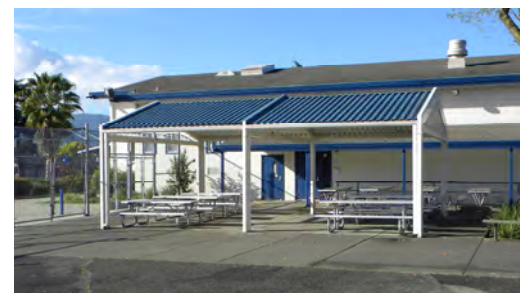
#### 58. STEAM Lab

There is a need for a STEAM lab at this campus.

It is recommended that a new STEAM classroom be constructed adjacent to the new modular classrooms.

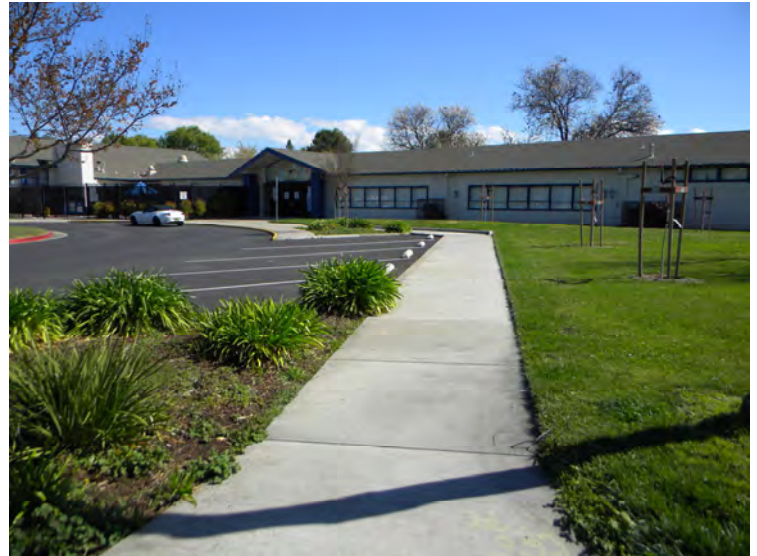
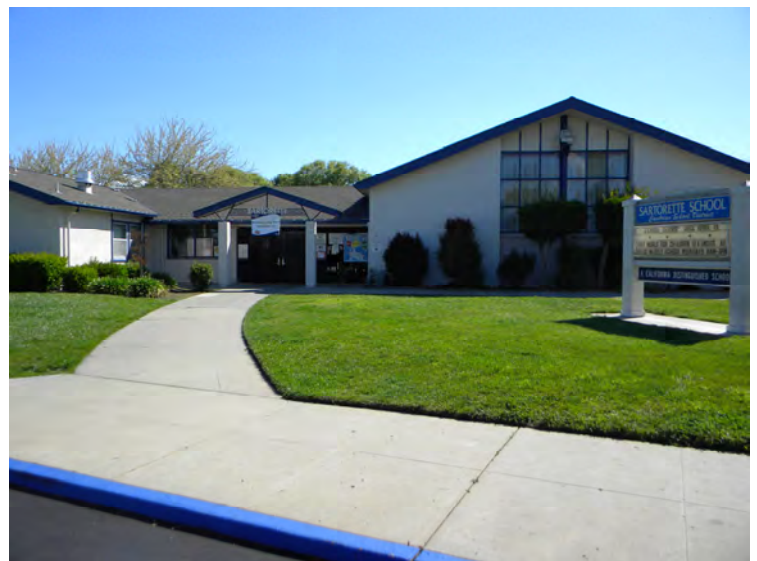
### 1. Parking and Traffic

The existing parking size and configuration at Sartorette has had some changes over the last thirty years. The flow of traffic inefficiently designed with a separate bus drop off area that exists adjacent to the entrance of the main parking lot. The condition of the pavement is in fair condition. The existing parking lot could be expanded and altered to be significantly more efficient.

The parking lot should be designed to have a better flow of traffic and a better dedicated drop off area for the parents that would allow them to pass as needed after dropping off or picking up their children. The existing parking area should be resurfaced with a new slurry seal and striping.

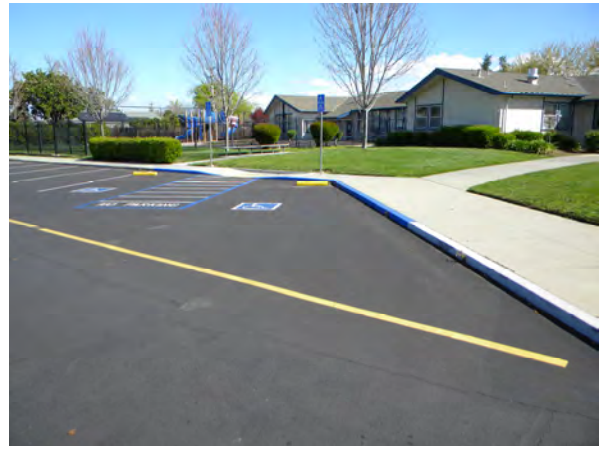
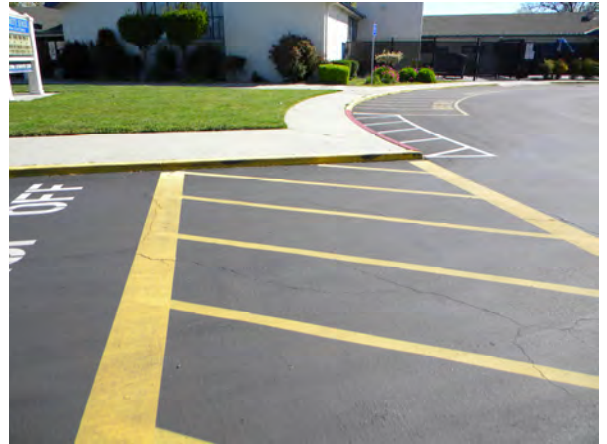
### 2. Site ADA Compliance

Some flatwork and walkways were upgraded in previous modernizations. There are locations where pavement has heaved or cracked in the ADA path of travel.

It is recommended that several portions of existing walkways in the ADA path of travel be repaired.

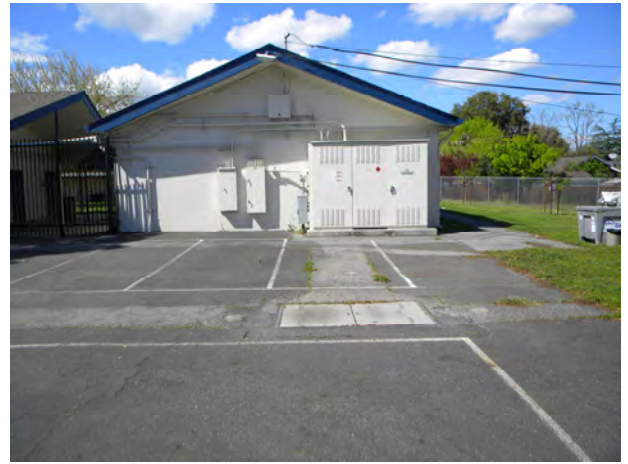
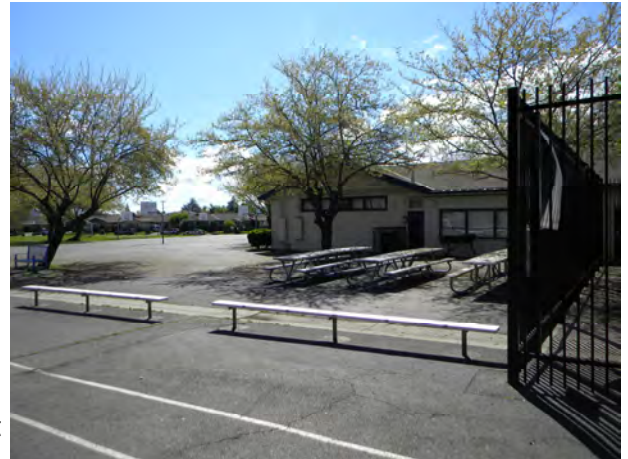
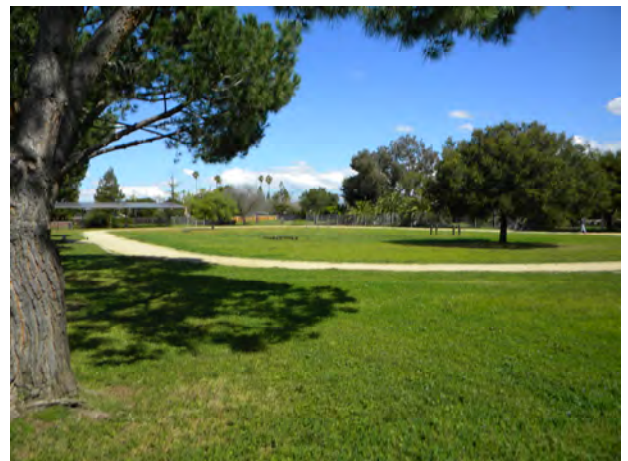
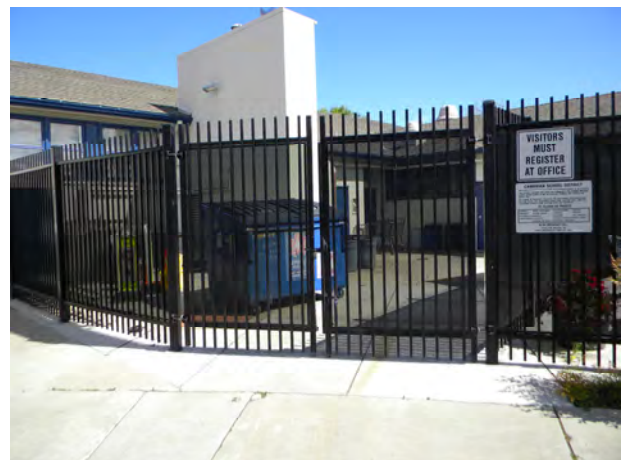
## 9. Site Utilities

Some of the underground utilities supplying gas and water to the site have been replaced. The existing sewer system is composed of an antiquated clay piping system which allows tree roots to grip and break existing underground piping. Some of the underground utilities have surpassed their intended service life. Replacing the underground utilities will drastically reduce the need for ongoing maintenance of these systems. Past modernizations and electrical upgrade routed new heavy electrical conduits on eaves, roofs, at the underside of vaulted ceilings and columns. The campus was not intended nor designed for these heavy conduits that blemish the campus.

It has been reported that this campus may need additional seismic gas shut offs. Domestic backflow preventor is on need of replacement.

It is recommended that all underground storm, sewer and some water lines under the existing kitchen be replaced at this site. It is recommended that all existing electrical conduits be removed from the eaves, roofs and columns throughout the campus and rerouted underground. The cost estimate will assume some additional seismic gas shut offs be added to this campus. The domestic water backflow is recommended to be replaced.

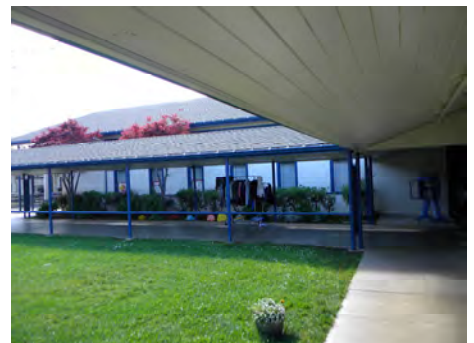
## 24. Building Insulation and Windows

The original campus buildings were constructed in an era when natural resources such as natural gas and electricity were inexpensive. Windows are single glazed throughout and insulation does not currently meet new construction standards. The window blinds have are older and need to be replaced.

It is recommended that insulation be added to all exterior walls and added to all ceiling cavities. Windows should be replaced with double glazed window systems retrofitted with new window blinds.

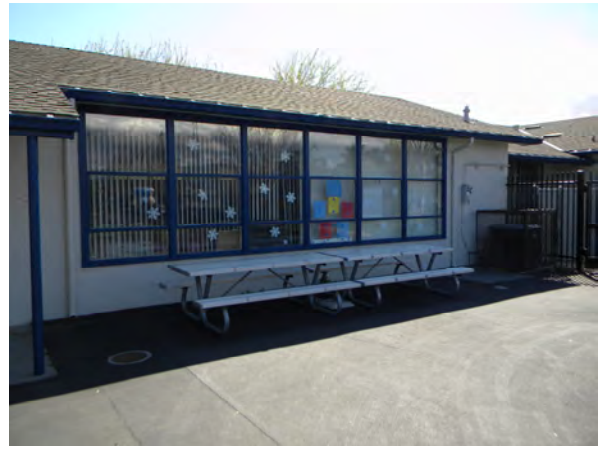
## 25. Exterior Doors and Hardware

The campus hardware and doors are in good condition, however the existing locking system does not currently meet the District's requirements for appropriate security. There are some doors that will need to be replaced due to heavy usage and damage over the years.

It is recommended that all hardware be replaced with District Standard secure hardware throughout this campus. It is assumed that several existing doors will need to be replaced to make appropriate alterations for the new hardware installation. The cost estimate will make an assumption for the number of replacements needed.

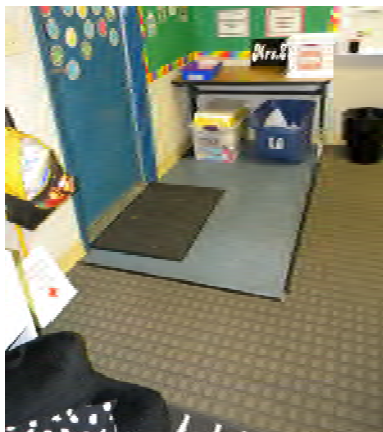
## 27. Flooring

Most of the flooring is in good condition.

It is recommended that the entire campus flooring be replaced in the next ten years.

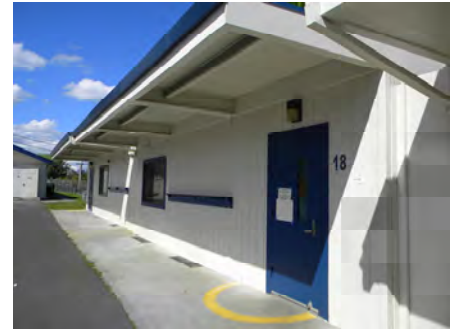
## 56. Covered Eating Structure or Outdoor learning

The only existing covered area is a small metal shade structure adjacent to the cafeteria. The location of the existing photovoltaic structures are not located allowing these to function as outdoor learning nor eating structures. The existing space adjacent to the cafeteria could incorporate outdoor learning. It would be desirable to have one or two more covered outdoor learning and eating spaces strategically located throughout this campus.

It is recommended that two large covered metal shade structures at other locations on this campus equipped with wi-fi and outdoor furnishings be installed at this campus.

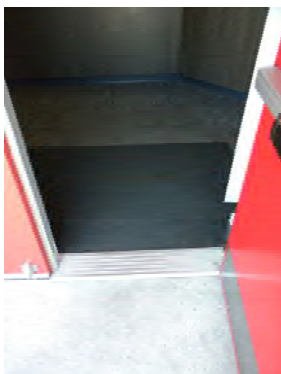
### 2. Site ADA Compliance

The only known issues at Bagby is that the DA lift at the stage area of the existing Multi-purpose room is not functioning and is in need of repair.

It is recommended that the DA lift be repaired.

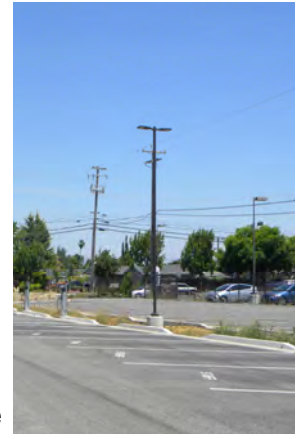
## 12. Site Lighting

The existing lighting was upgraded in 2016. There is no known reason for additional site lighting at this time.

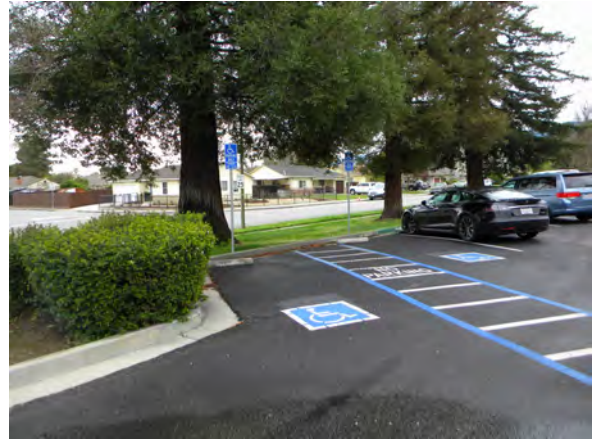
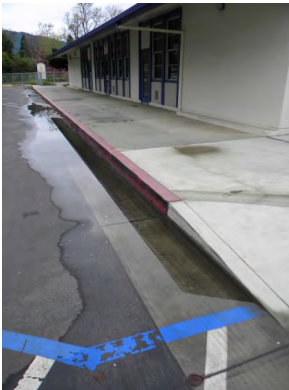
## 1. Parking and Traffic

The existing parking lot was reconfigured and updated with new striping when the Photovoltaic Canopies were installed in 2014. The parking lot is too small for large events. Many visitors park in the street. The MOT area has AC pavement that is in need of an overlay.

It is recommended that the front parking lot be altered and combined with the existing smaller parking lot. The front parking lot should be widened toward the street to allow for double-loaded parking. It is recommended that the MOT parking area receive a slurry seal and restriping.
