# Cambrian School District Facilities Needs Assessment & Master Plan

February 2021

*Facilities Needs Assessment & Master Plan 2021*

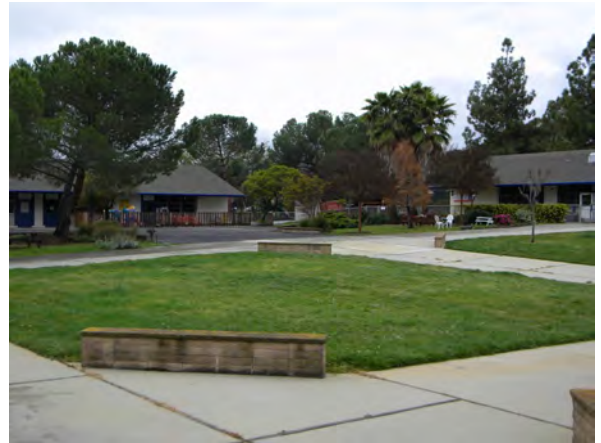
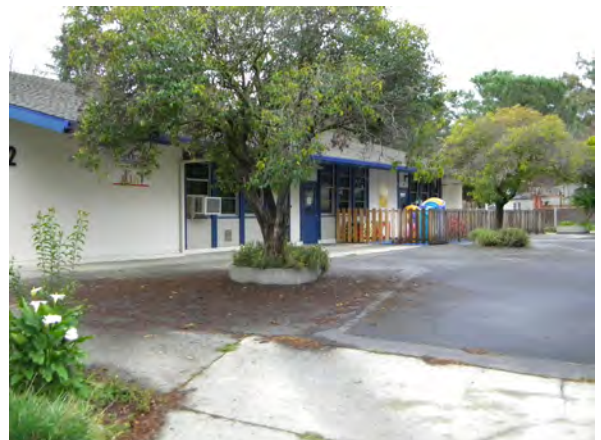
This facility has a large amount of mature trees located at various locations throughout this older site which require ongoing trimming. Landscaping is in fair condition. The District would like to upgrade landscaping with drought tolerant native plants that require less water. Irrigation controls and valves are in need of replacement.

It is recommended that all mature trees be trimmed as required and that all plantings be replaced with drought tolerant natives. All valves and irrigation controls should be replaced.

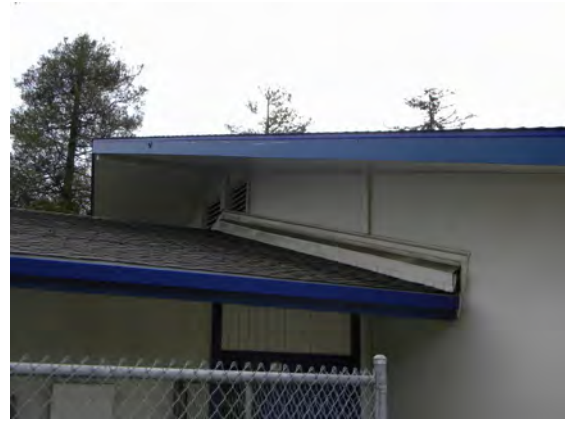
## 22. Roofing

Based on the roofing report, all roofing is in good condition as it was reportedly installed in 2007. It was noted that leaves and debris have filled some gutters. The whirly birds are in need of replacement.

It is recommended maintenance toward cleaning roofs free of leaves and debris and replacing several damaged or missing shingles selectively throughout this campus. All whirly birds are recommended to be replaced.

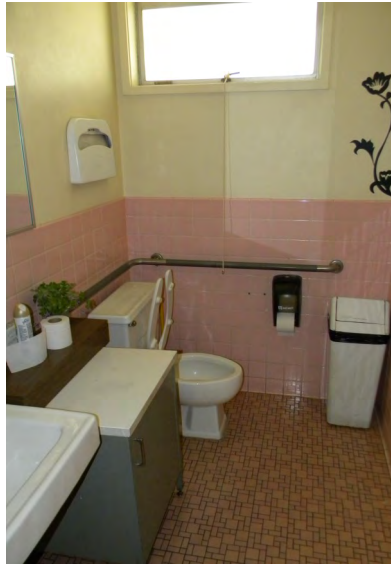
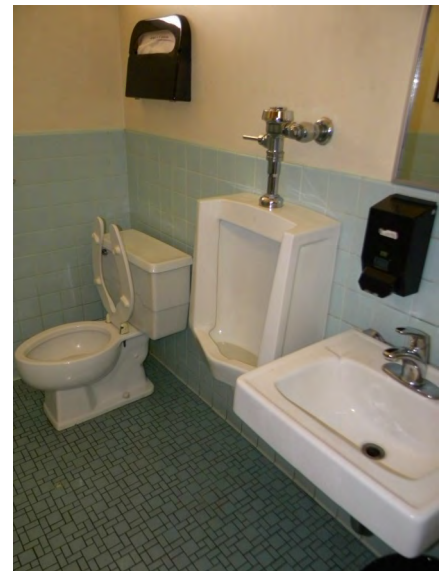
## 27. Flooring

Most of the flooring is in fair condition.

It is recommended that the entire facility flooring be replaced in the next five years.

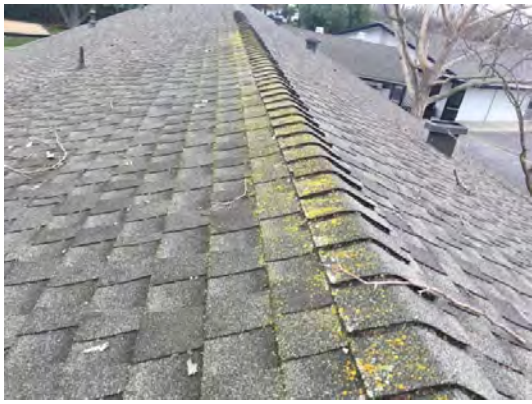
*Photo 3*

Lichen growth due to prolonged shade and moisture.

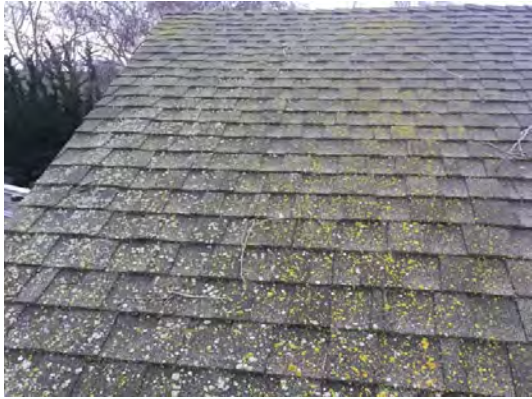
*Photo 4*

Lichen growth in shaded areas.

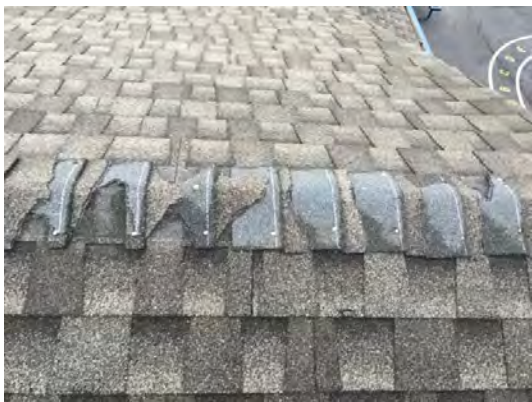
*Photo 5*

**Shingle Deterioration:** As organic three-tab shingles are exposed to the elements they become brittle and shrink. This in turn causes the shingle to "crumble" and "curl". Once the mineral surfacing "crumbles" apart it exposes the underlying organic felt, which rapidly deteriorate when exposed to freeze/thaw cycles. This in turn allows ice and water to enter the building causing internal damage and leaks.

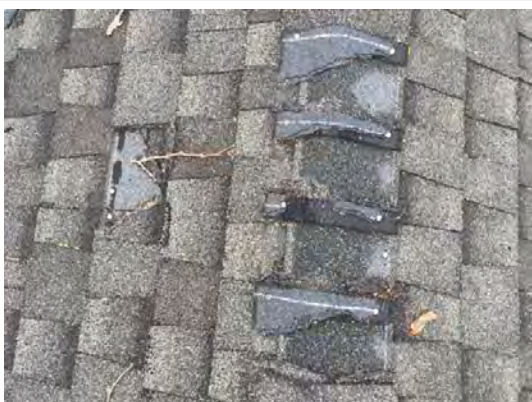
*Photo 6*

Shingle damage. Exposed nails can lead to thermal bridging and leaks.

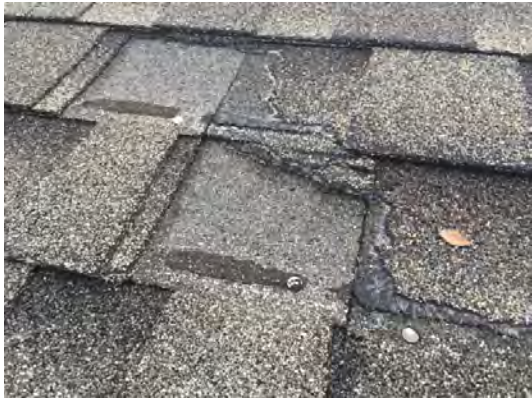
*Photo 7*

Missing shingles. Exposed nails fasteners.

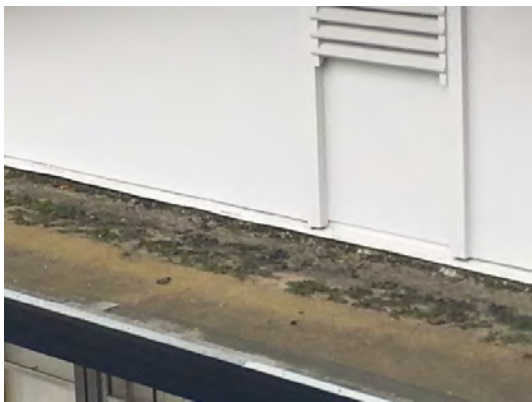
*Photo 9*

Debris and moss build up leads to prolonged moisture increasing the rate of deterioration.

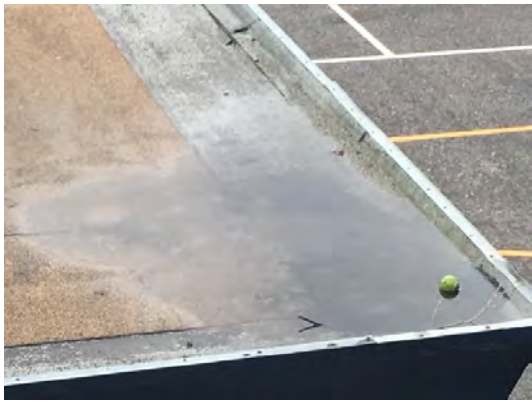
*Photo 10*

**Ponding:** Ponding water occurs when moisture collects in large pools on the surface of a roof system. These pools begin to form because of two reasons: 1) roof drains are blocked or clogged with debris, 2) the insulation package has lost dimensional stability and has reduced in thickness, 3) poor slope to drain design via overbuilt crickets or tapered insulation system, 4) roof drains are built along side building support columns which maintain a consistent height under load while the balance of the roof system is applied over a live deck which tends to move and deflect under normal seasonal load. In all cases, roof depressions that collect and hold water will tend to grow in size as the added weight of the ponding water will continue to deflect the roof deck even further.

This condition can damage the roof in a number of ways. Additional structural loads create more movement of the roof assembly creating more tear stress and of course a potential for structural failure. UV intensity also increases under ponding conditions as the sun's rays are increased to the point where it accelerates deterioration in most all roof systems. In asphalt based assemblies the natural waterproofing oils in the asphalt will separate from the membrane if the system remains submerged under water for sustained periods. Single ply roof system rot and burn out when the ponding area is exposed to sunlight. The added weight can crush insulation increasing the ponding condition and creating a condition where the insulation becomes a useless thermal barrier. This condition then affects the mechanical system and the cost of heating and cooling the building. In the winter ponding water will expand as it freezes. This expansion will weaken small imperfections in the roof system. Small cracks and tears will widen until they rupture to allow water into the building. And finally, a negatively deflected deck becomes a structural concern.

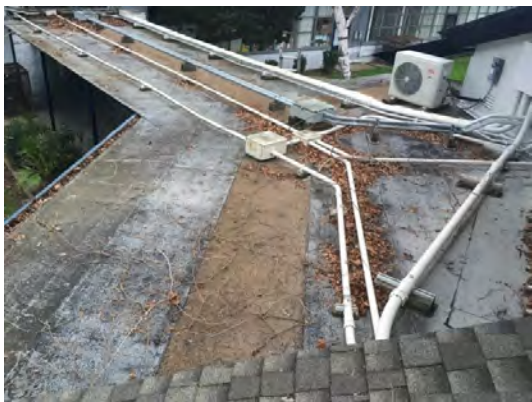
*Photo 11*

<b>Rating</b>	Fair
<b>Condition</b>	The shingle roofs are in fair condition as they were installed in 2002. Some minor shingle repairs are recommended. The BUR walkway roofs are in poor condition and should be replaced.

Aged BUR covered walkway.

Replace 5,505 sq.ft. of BUR covered walkway roofs. Install Garland's 2 ply Stress Ply E (Environmental) flood coated with White Star and Garvel. 30 year warranty.

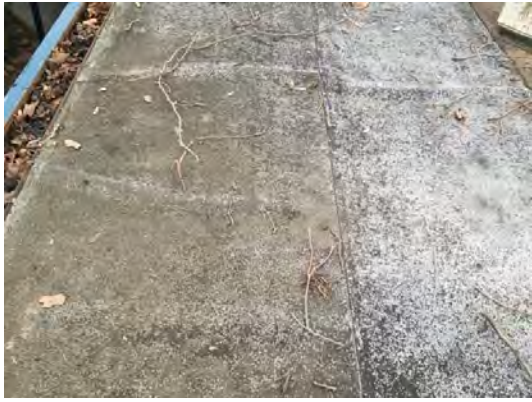
*Photo 12*

**Mineral Roof Granule Deterioration:** It is very common for mineral finished roofs to experience bare felts as early as five years after installation. Manufacturing quality control issues as well as weather "washing off" the factory applied mineral coating causes these areas. Typically this is indicated by accumulations of mineral where ponding is present. Bare felts cause exposure of the membrane to the sun/UV rays, which cause rapid membrane deterioration. Therefore, it is extremely important to coat these areas as soon as they appear.

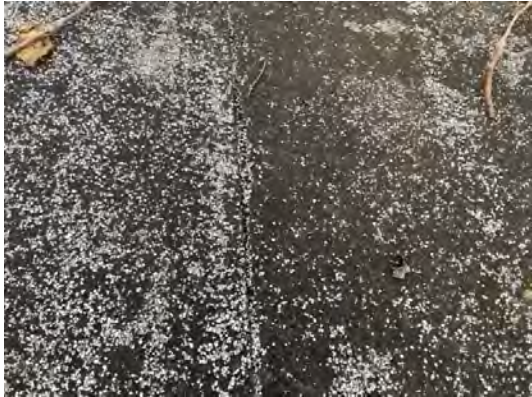
*Photo 13*

**Bare or Exposed Felts:** Weathering causes the roofs surfacing materials to oxidize and wear away after a period of time. Loss of protection from the surfacing material results in accelerated deterioration of the primary waterpoofer asphalt, along with the systems reinforcement plies which provide the strength for the system. Heat and UV rays dry out unprotected asphalt which then leave the bare reinforcement plies exposed to the elements. The exposed reinforcement will begin to absorb and wick moisture into the built up layers of the roof system. This condition leads to accelerated damage via blisters and interlayer delamination. Roof system damage occurs when these weakened areas of the roof system are affected by thermal shock, typical roof traffic and normal seasonal conditions.

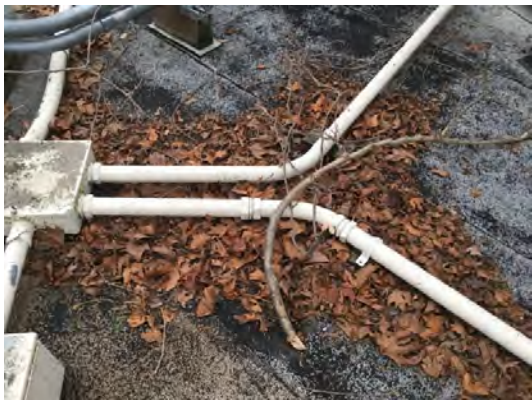
*Photo 14*

**Debris - Leafs and Pine Needles:** Pine needles and other leaves build up on the roof membrane causing plugged drains and scuppers thereby causing ponding water and structural weight loading. As the leaves and pine needles rot a "compost effect" occurs, this in effect causes soil to form on top of the roof membrane. This soil creates a perfect medium for plant and weed growth. When seeds take hold the roots will often penetrate through the membrane causing immediate leaks and damage internally.

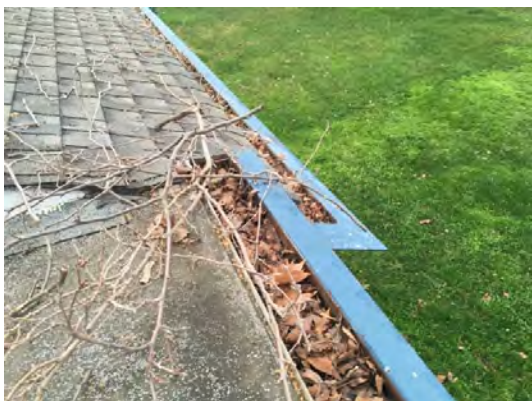
*Photo 15*

<b>Rating</b>	Fair
<b>Condition</b>	Leaves and debris have filled the gutters in some areas. The gutters should be cleared to prevent the downspouts from clogging.

The gutters have filled with leaves clogging the downspouts.

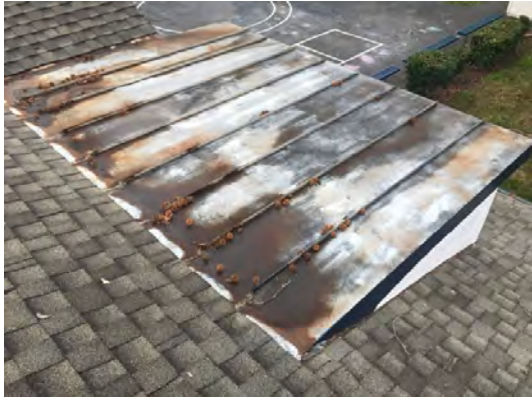
*Photo 16*

<b>Rating</b>	Good
<b>Condition</b>	The roof penetrations are in good condition. However, the rusted metal pop up roof should be restored and coated with White Knight Plus WC urethane.

Rusted metal roof section.

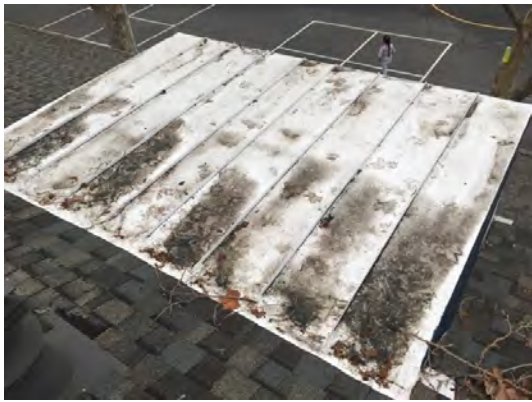
*Photo 17*

Restored metal roof section. The rust was treated with Rust-Go-Primer. The seams have been wrapped with Unibond adhesive tape. And the metal panels were coated with White Knight Plus WC urethane.

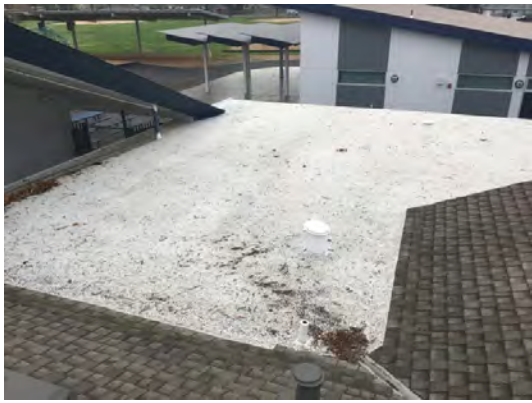
*Photo 18*

Staff room roof replaced with new BUR, flood coated with White Star and gravel. New roof looks good.

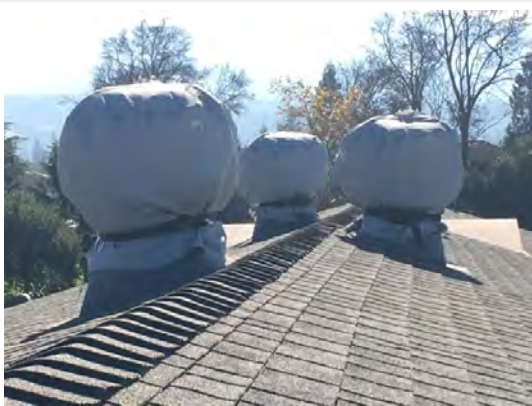
*Photo 6*

<b>Rating</b>	Fair
<b>Condition</b>	The whirly bids on the DO should be replaced.

DO whirly birds leak. Should be replaced with low rise vents.

<b>Rating</b>	Good
<b>Condition</b>	These roof are in good condition. The DO whirly bids should be replaced with low rise vents. No other recommendations at this time.

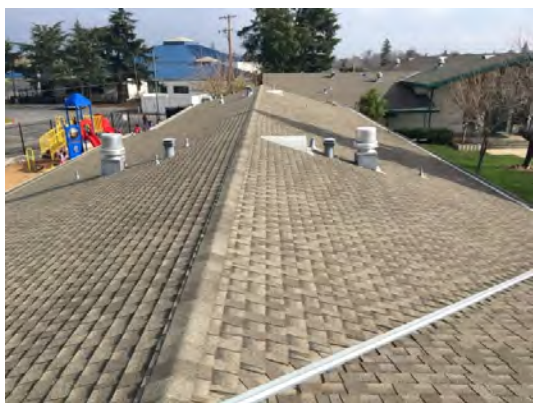
*Photo 1*

Shingle roof overview.

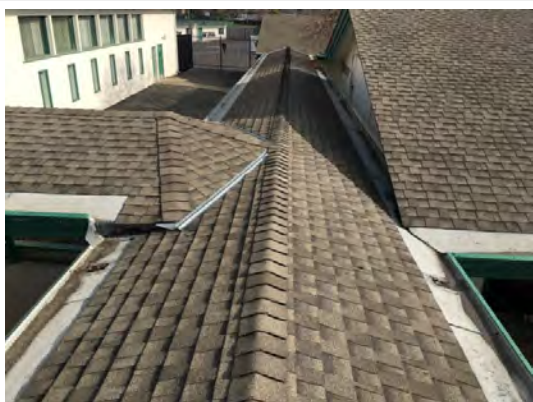
*Photo 2*

Shingle roofs overview.

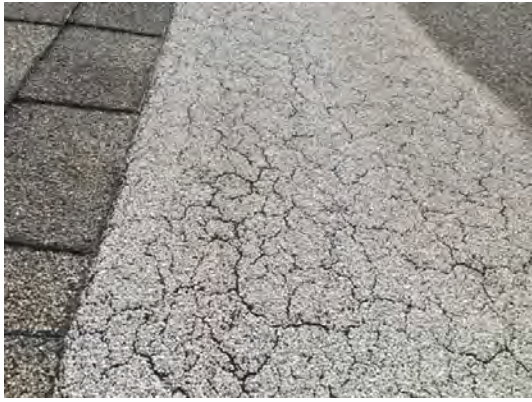
*Photo 3*

Shingle walkway overview.

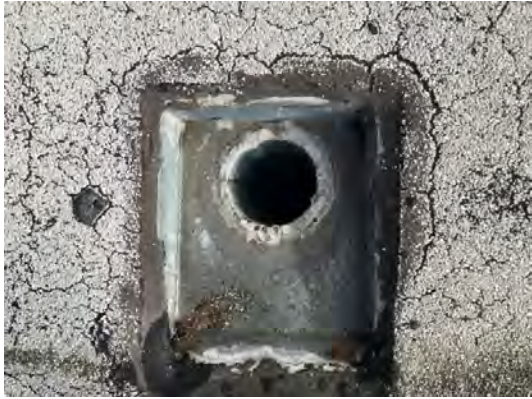
*Photo 4*

<b>Rating</b>	Fair
<b>Condition</b>	The perimeter membrane has begun to crack and deteriorate. Restoring the perimeter is recommend before replacement is required.

Perimeter membrane cracking due to UV deterioration.

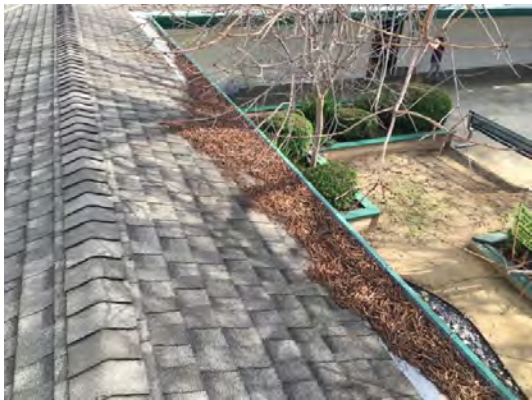
*Photo 5*

**Condition** Leaves and debris have collected around the perimeter and drains. Drains screens should be installed to prevent the downspouts from clogging.

Missing drain screen.

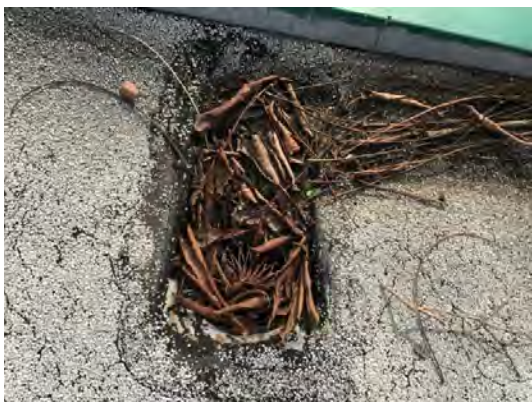
*Photo 6*

**Debris - Leafs and Pine Needles:** Pine needles and other leaves build up on the roof membrane causing plugged drains and scuppers thereby causing ponding water and structural weight loading. As the leaves and pine needles rot a "compost effect" occurs, this in effect causes soil to form on top of the roof membrane. This soil creates a perfect medium for plant and weed growth. When seeds take hold the roots will often penetrate through the membrane causing immediate leaks and damage internally.

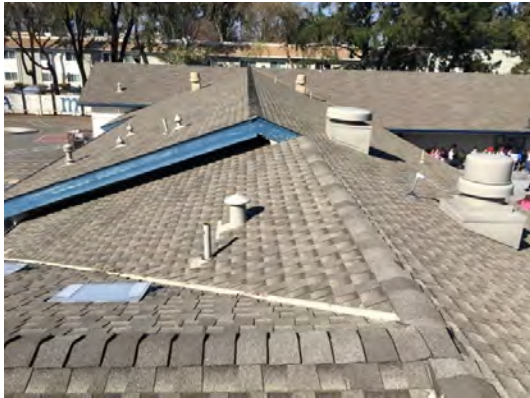
*Photo 1*

Shingle roof overview.

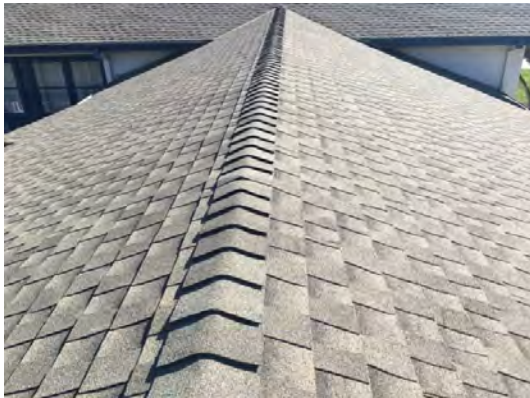
*Photo 2*

Shingle roofs in good condition.

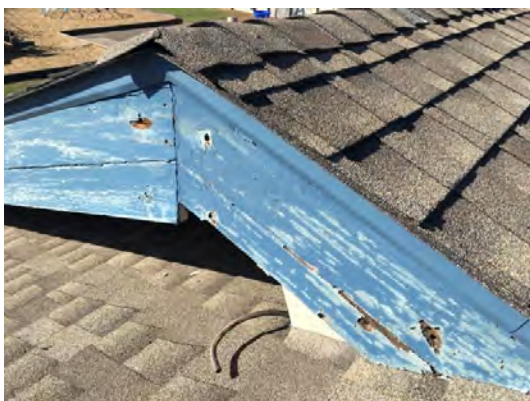
*Photo 3*

Wood fascia deterioration. A metal fascia cover would protect the wood substrate and eliminate maintenance and repainting.

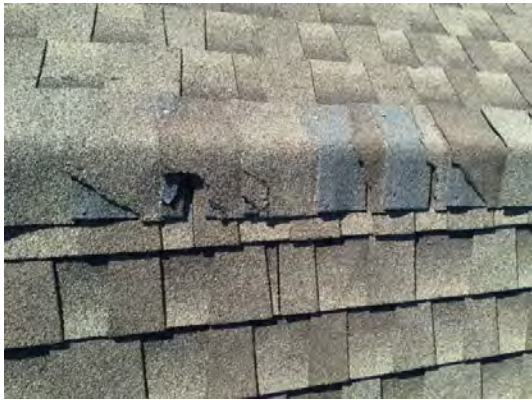
*Photo 4*

<b>Rating</b>	Good
<b>Condition</b>	The shingle roofs are in good condition. Some damaged/missing shingles are present and should be replaced.

Damaged shingles. Exposed nail fasteners may cause leaks.

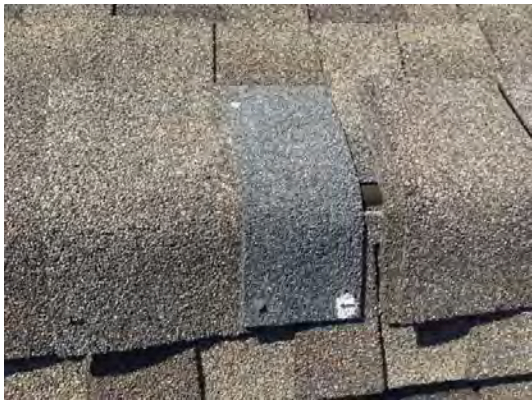
*Photo 5*

Exposed nail fasteners.

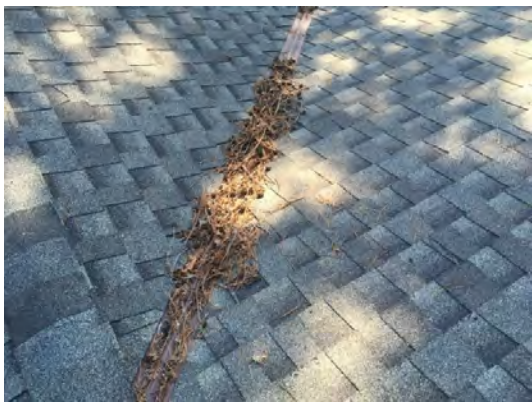
*Photo 6*

**Debris - Leafs and Pine Needles:** Pine needles and other leaves build up on the roof membrane causing plugged drains and scuppers thereby causing ponding water and structural weight loading. As the leaves and pine needles rot a "compost effect" occurs, this in effect causes soil to form on top of the roof membrane. This soil creates a perfect medium for plant and weed growth. When seeds take hold the roots will often penetrate through the membrane causing immediate leaks and damage internally.

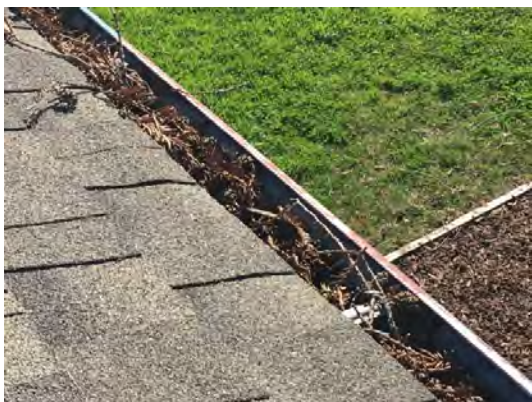
*Photo 7*

<b>Rating</b>	Fair
<b>Condition</b>	Leaves and debris have filled some gutters. The gutters should be cleared to prevent the downspouts from clogging.

The gutter has filled with leaves and may clog the downspout.

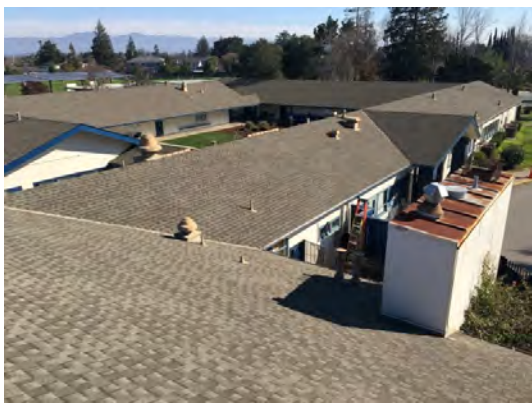
*Photo 8*

Chimney cap overview.

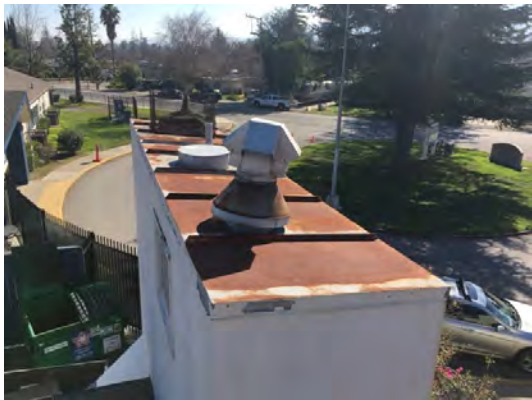
*Photo 9*

<b>Rating</b>	Fair
<b>Condition</b>	The chimney roof cap is rusted and deteriorating. The metal cap should be restored or replaced.

Rusted chimney metal should be restored or replaced.

Restore portable 18 metal roof, and the rusted metal chimney cap. Clean roofs, remove old mastic, treat rust with a wire brush and Rust-Go-Primer. Prime portable roof with White Knight Metal Primer. Seal all seams with Unibond ST adhesive tape. Coat entire roof area with White Knight Plus WC urethane. 10 year warranty.

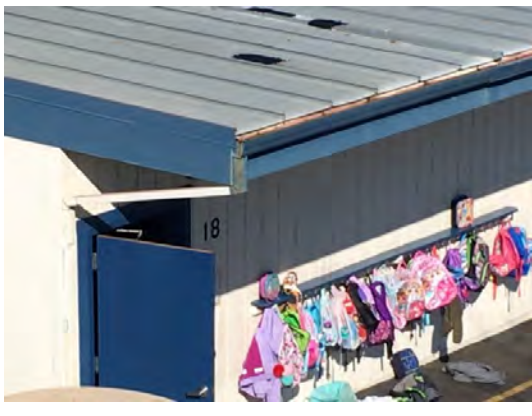
*Photo 10*

Portable 18 roof leaks.

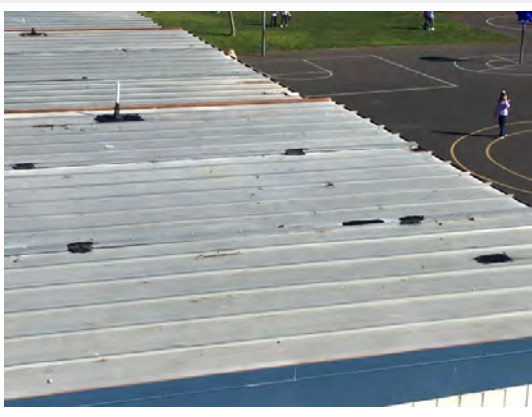
*Photo 11*

Black mastic repairs are not a long term solution for metal roofs. The leaking seams should be sealed with Unibond adhesive tape and coated with White Knight Plus WC urethane.

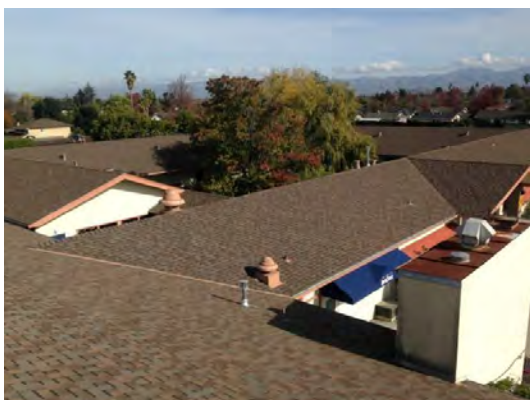
*Photo 2*

Overview of shingle roof system.

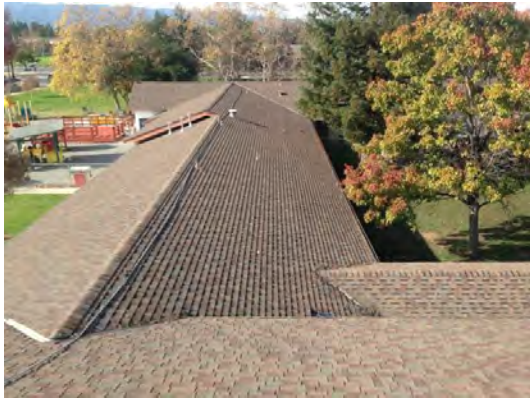
*Photo 3*

Overview of shingle roof system.

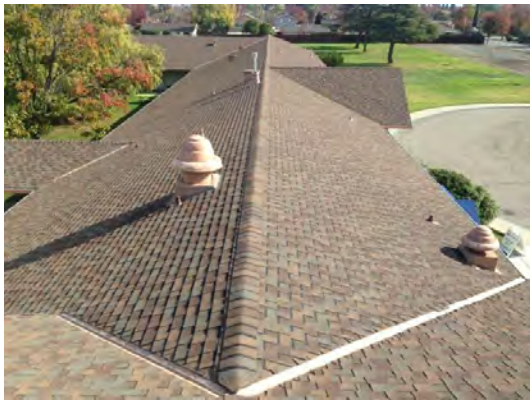
*Photo 4*

Overview of shingle roof system and penetrations.

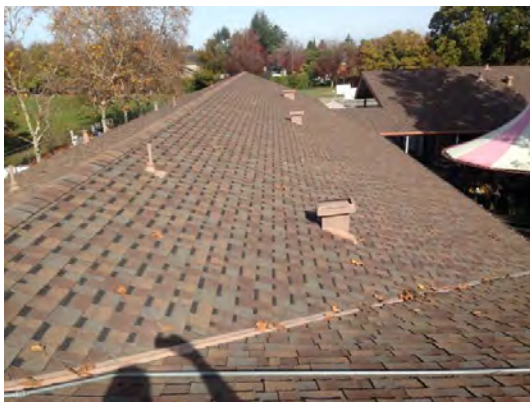
*Photo 5*

Overview of shingle roof system and penetrations.

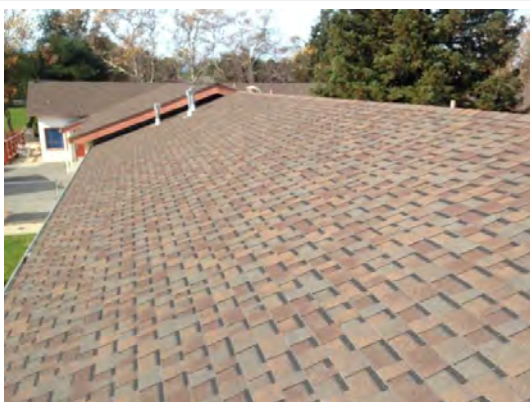
*Photo 6*

**Shingle Deterioration:** As shingles are exposed to the elements they become brittle and shrink. This in turn causes the shingle to "crumble" and "curl". Once the mineral surfacing "crumbles" apart it exposes the underlying felt, which rapidly deteriorate when exposed to UV rays. This in turn allows water to enter the building causing internal damage and leaks.

These roofs are ideal for a metal roof system. Install Garland's R-Mer Span standing seam metal roof panels. Tear off roof to the deck, inspect and repair any dry rot in kind. Install R-Mer Seal self adhering underlayment and new 22g steel R-Mer Span standing seam roof system with new R-Mer Edge gutters. Install proper ridge venting as required by code. This options comes with a 30 year warranty.

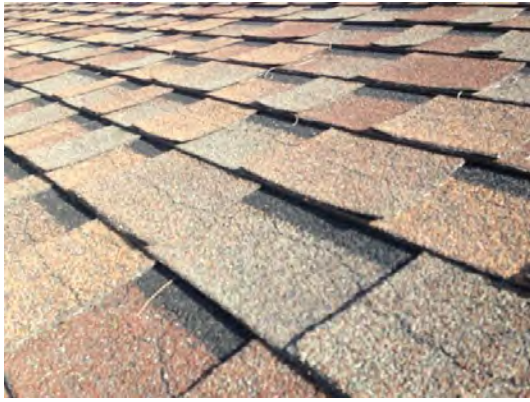
*Photo 7*

<b>Rating</b>	Poor
<b>Condition</b>	The shingles have become brittle and developed cracks. Surface mineral loss has began and will increase the rate of deterioration. UV rays and weathering will continue to break down the shingles. A new roof system is needed to create a long term solution.

Shingle deterioration and cracking.

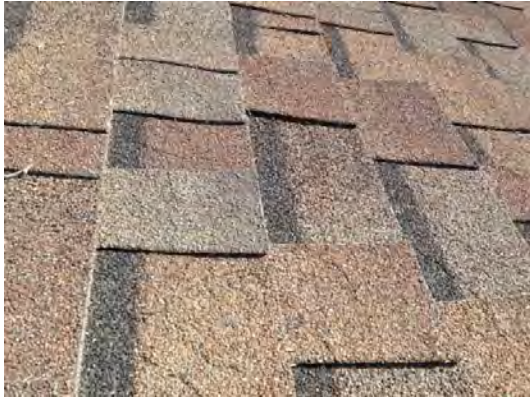
*Photo 8*

Cracking and surface mineral loss throughout the shingle roofs.

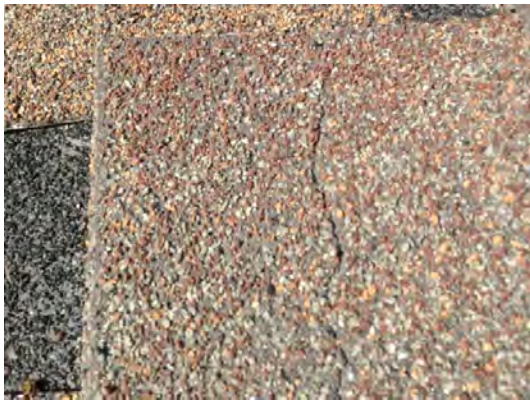
*Photo 9*

Shingle deterioration and surface mineral loss.

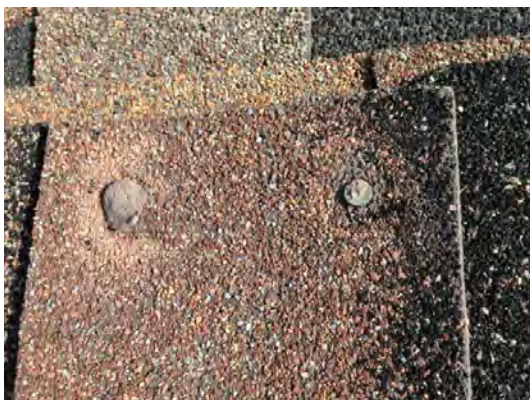
*Photo 10*

<b>Rating</b>	Good
<b>Condition</b>	The roof penetrations are in good condition. However, nail punctures are present on the ridges. Nail punctures should be sealed properly to prevent thermal expansion and contraction. Moisture may enter the roof system and these location causing leaks and internal damage.

Nail penetrations in shingle.

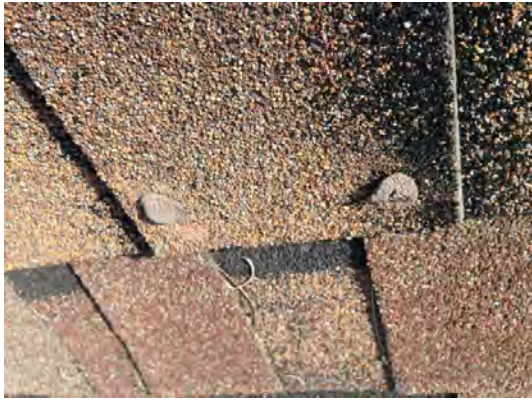
*Photo 11*

Roof punctures allow direct water entry points.

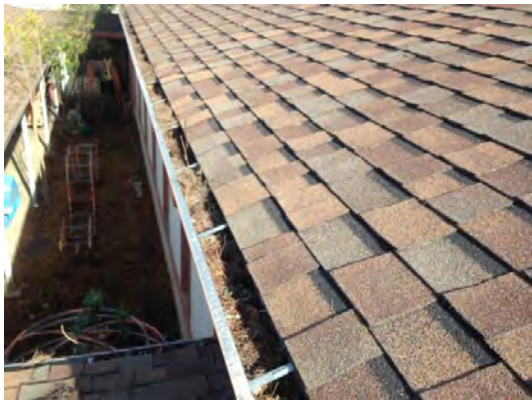
*Photo 12*

**Debris - Leafs and Pine Needles:** Pine needles and other leaves build up on the roof membrane causing plugged drains and scuppers thereby causing ponding water and structural weight loading. As the leaves and pine needles rot a "compost effect" occurs, this in effect causes soil to form on top of the roof membrane. This soil creates a perfect medium for plant and weed growth. When seeds take hold the roots will often penetrate through the membrane causing immediate leaks and damage internally.

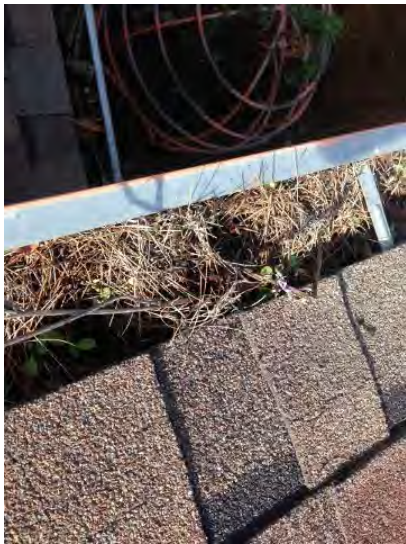
*Photo 13*

<b>Rating</b>	Fair
<b>Condition</b>	The gutters have filled with leaves and debris threatening to clog the downspouts and spill over. Some rust corrosion is also evident. Proper maintenance of the gutters ensuring the downspouts are clear is necessary to prevent heavy weight loads and gutter failure.

The gutters have filled with leaves threatening to clog the downspouts.

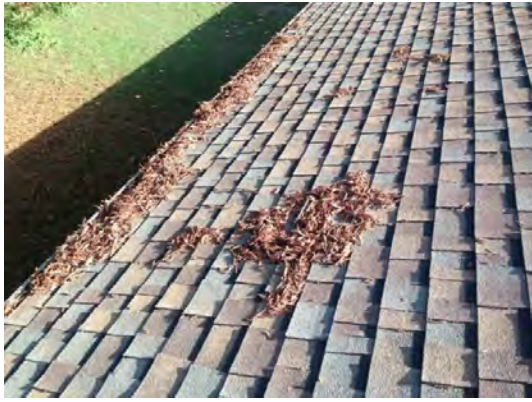
*Photo 14*

Leaves and debris.

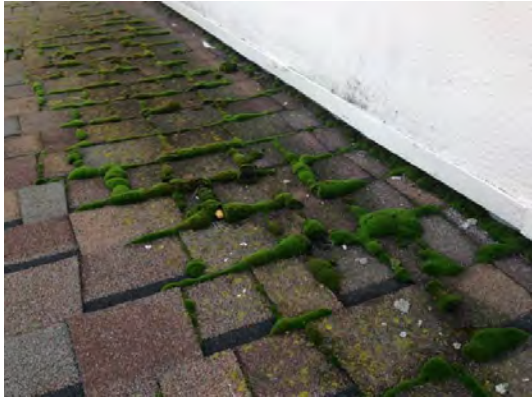
*Photo 15*

<b>Rating</b>	Fair
<b>Condition</b>	These roofs have adequate slope promoting the proper flow of water. However, some vegetation growth has developed in the shaded areas suggesting prolonged moisture.

**Vegetation Growth:** Vegetation often occurs when dirt and debris collect on roof systems. Over time this creates a perfect medium for plant and weed growth. When seeds take hold the roots will often penetrate through the membrane causing immediate leaks and damage internally.

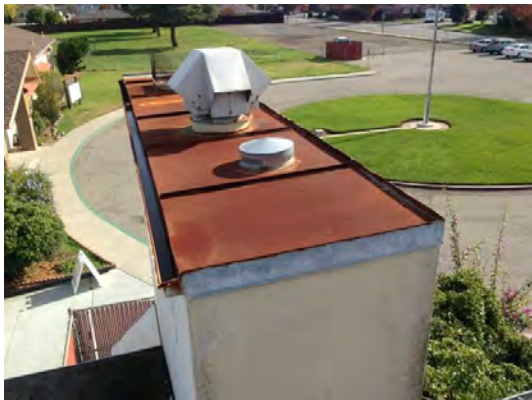
*Photo 16*

**Metal Panel Corrosion:** This condition is typically instigated by outside contaminants or geographic conditions such as proximity to salt water. Panel corrosion is a structural issue for the roof system and needs to be remedied at the earliest time possible to avoid roof failure and interior damage.

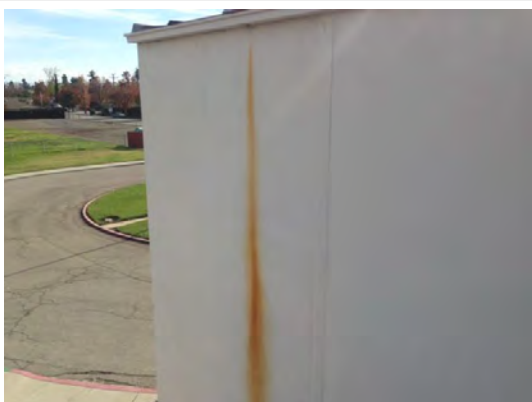
*Photo 17*

Rust stains along wall due to gutter leak.

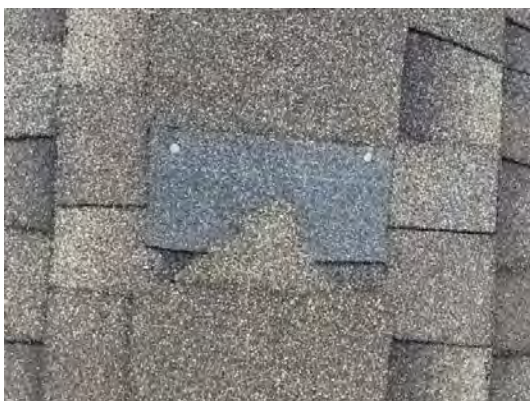
*Photo 3*

Shingle roof damage. Exposed nail fasteners can cause leaks.

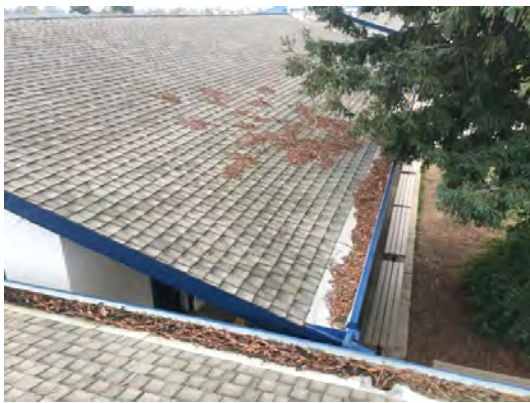
*Photo 6*

**Debris - Leafs and Pine Needles:** Pine needles and other leaves build up on the roof membrane causing plugged drains and scuppers thereby causing ponding water and structural weight loading. As the leaves and pine needles rot a "compost effect" occurs, this in effect causes soil to form on top of the roof membrane. This soil creates a perfect medium for plant and weed growth. When seeds take hold the roots will often penetrate through the membrane causing immediate leaks and damage internally.

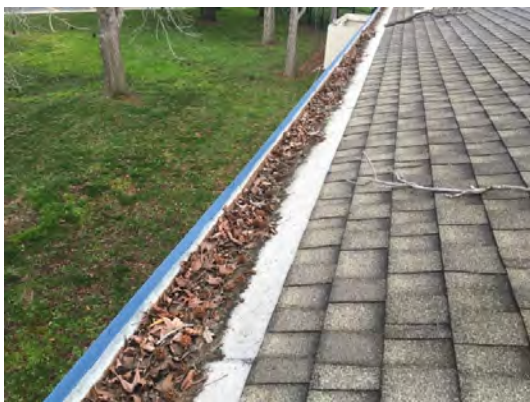
*Photo 7*

Leaves along drainage prolong moisture and increase the rate of membrane deterioration.

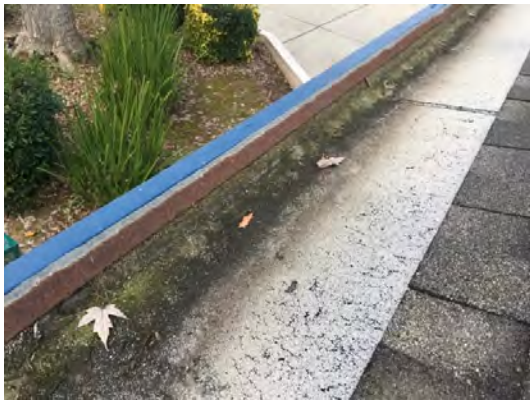
*Photo 8*

**Perimeter Flashing Deterioration:** Most roof failures start at perimeter and penetration locations. Metal edge conditions that are poorly designed and improperly installed fail due to the extreme expansion and contraction that is typical with metal. Perimeter wall flashings can also be damaged due to normal seasonal building movement and thermal shock. Additional damage can also be seen from UV degradation as well. At all of these deteriorated or failed points, moisture can gain direct access to the roof system insulation and the buildings interior.

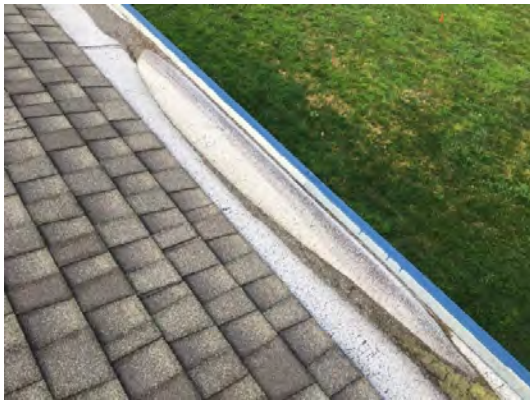
*Photo 9*

**Blisters:** Soft spongy pockets or swellings in the roofing material. They occur between layers of felt or between the roof membrane and substrate. Air or moisture vapor entrapped within a blister expands as the roof and outside air temperatures rise. This results in sufficient pressure to push the roofing felts upwards and apart. Blisters may be ruptured by roof traffic, expanding frozen water, or hail (especially during colder weather). Some blisters may become so large as to affect drainage, which may then cause ponding water. Laps could also be pulled apart, resulting in leakage. A ruptured blister will immediately allow water to penetrate and damage the roof system.

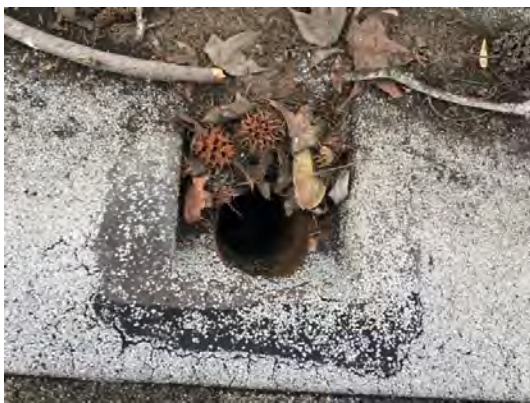
*Photo 10*

Screen caps should be installed to keep leaves from clogging the drains.

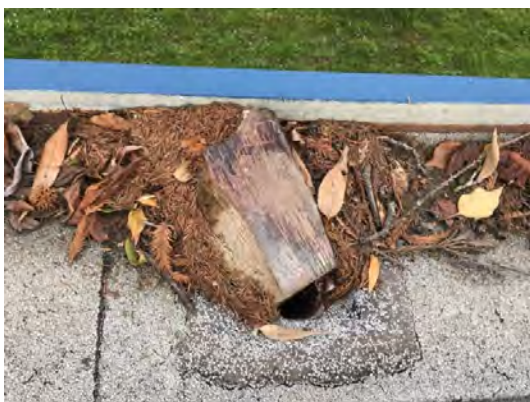
*Photo 11*

Screen caps should be installed to keep leaves from clogging the drains.

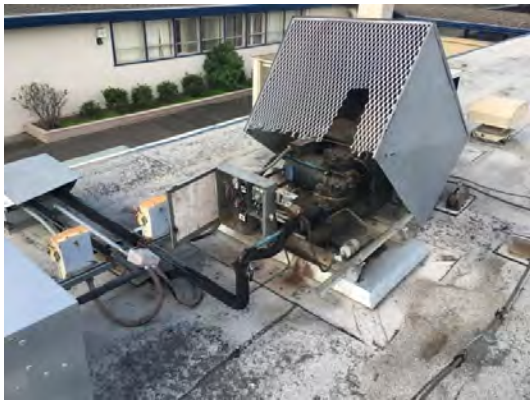
*Photo 13*

HVAC unit open and exposed.

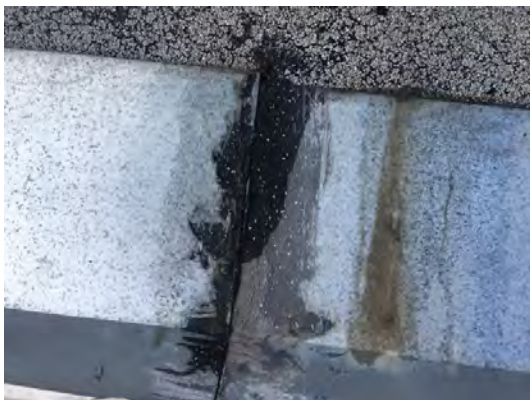
*Photo 14*

Perimeter flashing seams should be sealed properly.

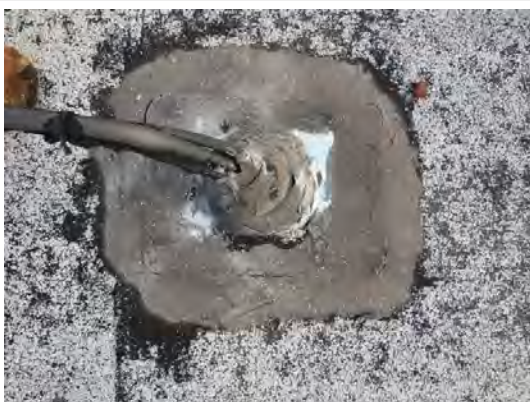
*Photo 15*

Mastic and caulking deterioration around penetration. Penetration should be sealed properly.

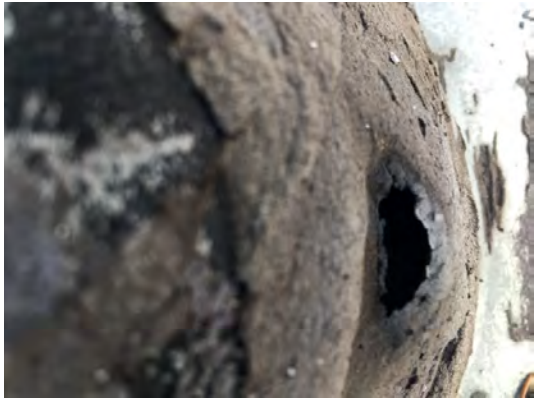
*Photo 16*

Hole in caulking may cause leaks.

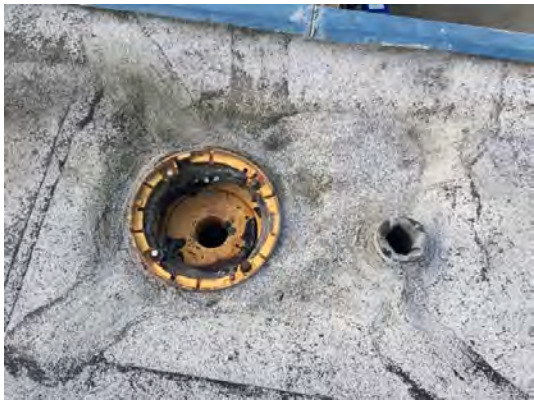
*Photo 17*

Drain cap missing.

Perform the necessary repairs and maintenance along the classroom wings and kitchen roof. Clean roofs free of leaves and debris. 3 course repair all blisters and BUR penetration seams with Silver-Flash and Gar-mesh. Coat the expansion cap covers with White Knight Plus WC. Restore deteriorated BUR perimeter primed with Garla-Block and coated with White Knight Plus WC. Replace missing drain screens.

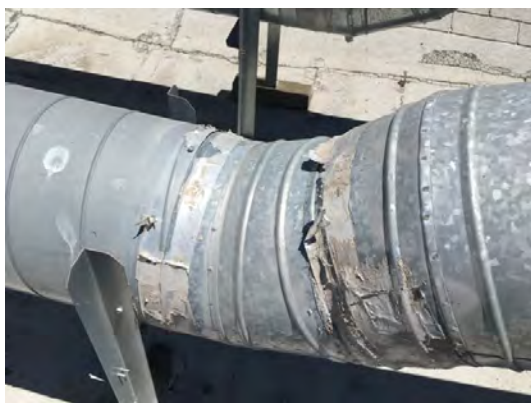
*Photo 2*

Duct seam tape deterioration.

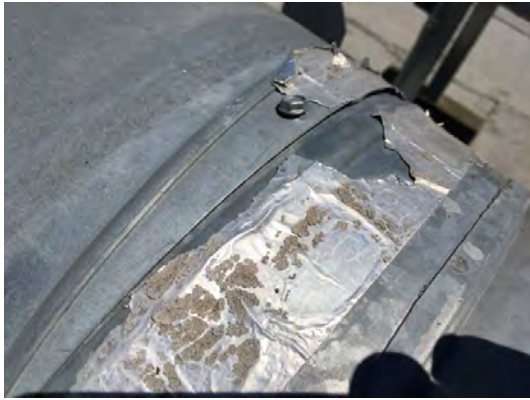
*Photo 3*

Seam tape deterioration. Water may enter the duct seams and leak into the vents and building below.

Perform the necessary repairs and maintenance on the BUR sections at Price Community Center. Clean roof free of debris and old mastic repairs. 3 course all curb and penetration seams with Silver-Flash and GarMesh. Seal all deteriorated duct seams with Unibond ST adhesive tape coated with White Knight Plus WC urethane. Restore all deteriorated base flashings and membrane seam laps with White Star and polyester fabric for reinforcement.

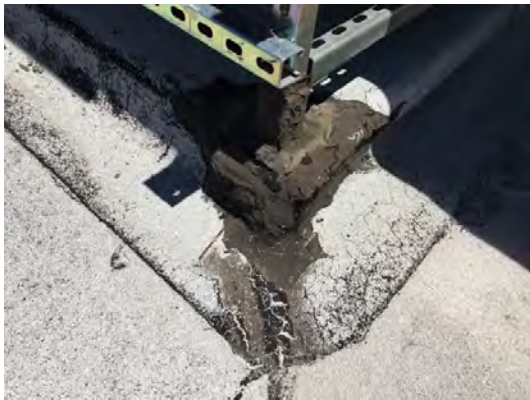
*Photo 4*

**Curb Flashing Deterioration:** The flashing on curbs and units is often the first area on a roof needing assistance. The inherent nature of an air handler unit running can cause tremendous vibration and movement in this area. This area should be monitored and checked frequently as it can allow water to enter buildings if not inspected frequently. Further, this area is often left exposed to the elements and not covered by the final surfacing material due to it being a vertical rise. Coating these areas is often a necessary solution for long term building envelope performance.

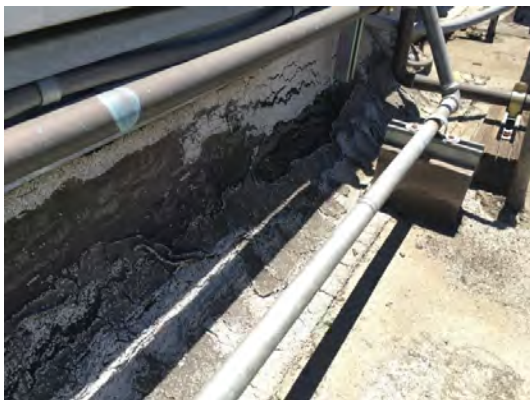
*Photo 5*

Overview of base flashing deterioration.

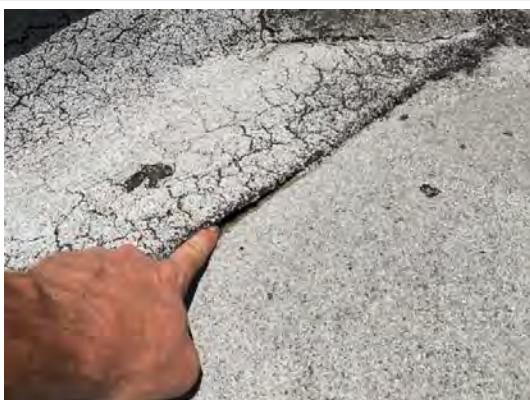
*Photo 6*

Loose seams along the base flashing.

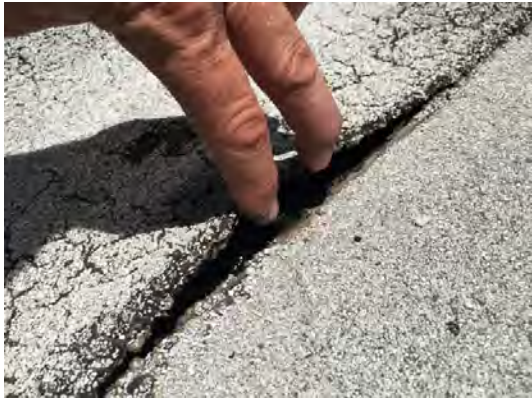
*Photo 7*

Loose seam laps along base flashing.

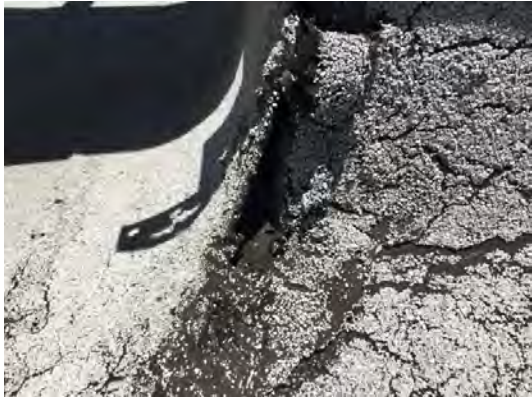
*Photo 8*

Open seam lap along curb.

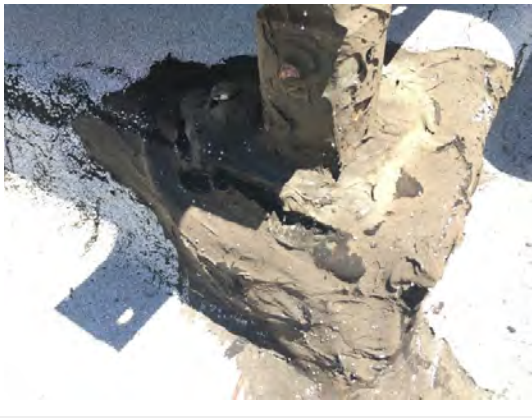
*Photo 9*

The previous repair mastic has cracked along the curb seam.

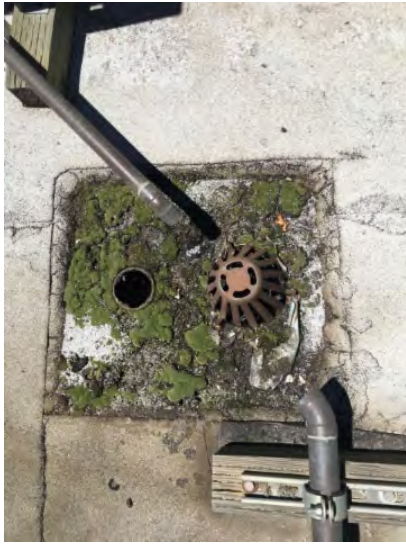
*Photo 10*

Debris in sump drain should be cleared regularly to prevent clogging.

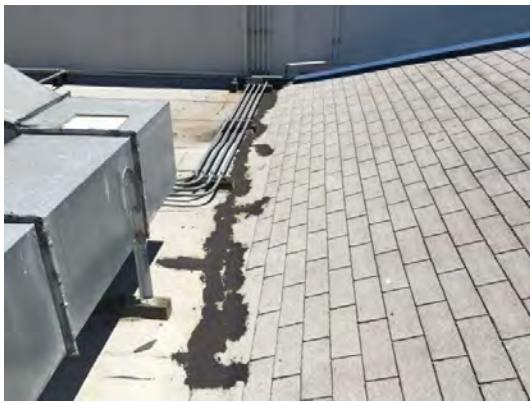
*Photo 11*

Henry mastic repairs along field seams. Proper repair is recommended if leaks persist. A reflective 3 course repair or membrane patch would result in a long term solution.

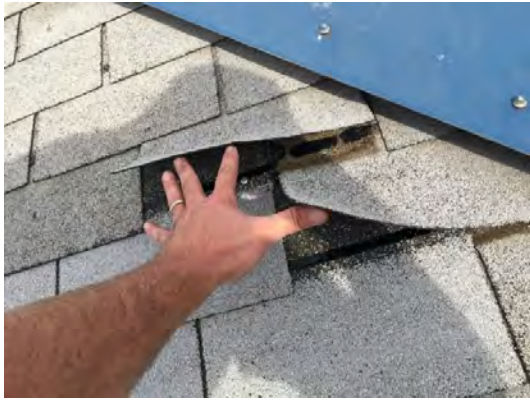
*Photo 3*

The loose shingles need to be adhered properly.

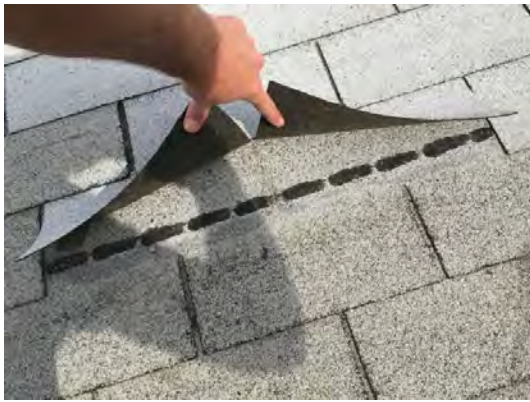
*Photo 4*

New shingles need to be adhered properly.

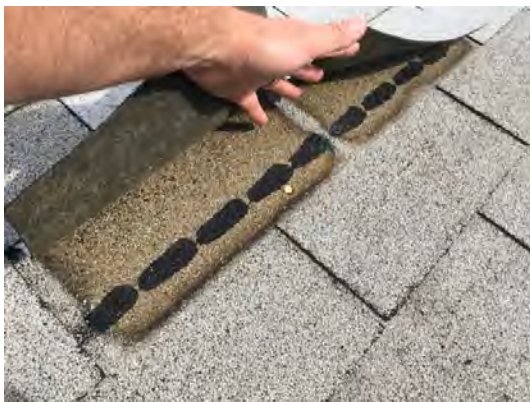
*Photo 5*

Replace shingles need to be adhered properly.

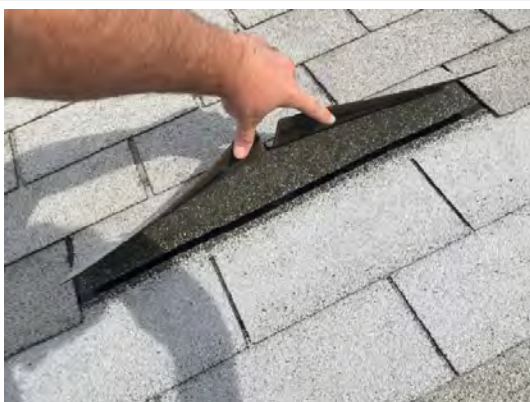
*Photo 6*

Perimeter shingles need to be adhered properly.

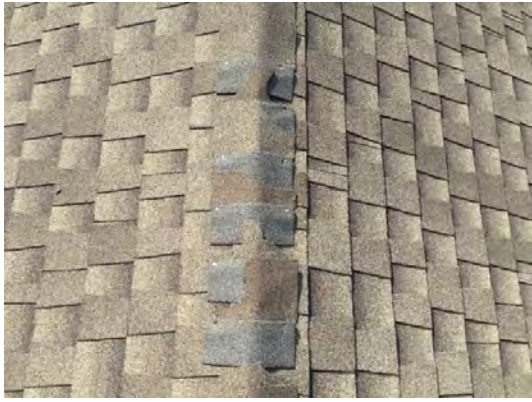
*Photo 3*

Missing shingles. Exposed nails may cause leaks.

Replace the damaged/missing shingles. Restore the metal chimney cap. Clean the chimney cap and treat with a wire brush and Rust-go-Primer. Seal all seams with Unibond St adhesive tape. Coat cap with White Knight Plus WC urethane.
