# Cambrian School District Facilities Needs Assessment & Master Plan

February 2021

*Facilities Needs Assessment & Master Plan 2021*

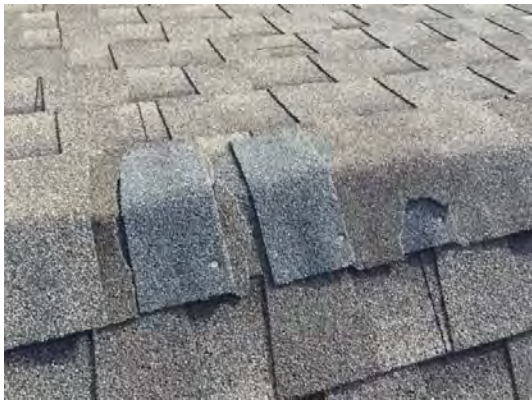
*Photo 4*

Damaged/missing shingles. Exposed nail fasteners may cause leaks.

Replace the damaged/missing shingles. Restore the metal chimney cap. Clean the chimney cap and treat with a wire brush and Rust-go-Primer. Seal all seams with Unibond St adhesive tape. Coat cap with White Knight Plus WC urethane.

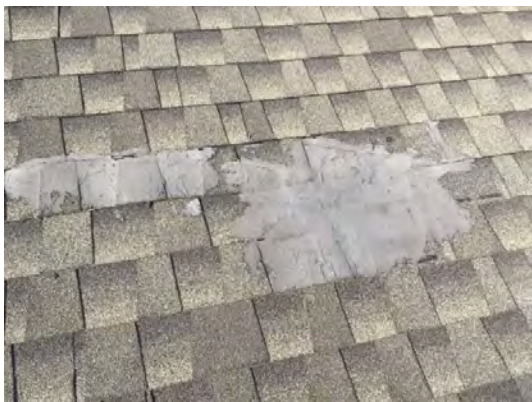
*Photo 5*

Mastic repairs over shingles should be replaced with new shingles.

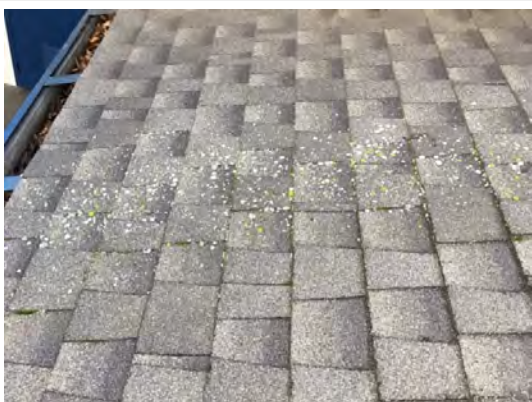
*Photo 6*

Lichen growth in shaded areas.

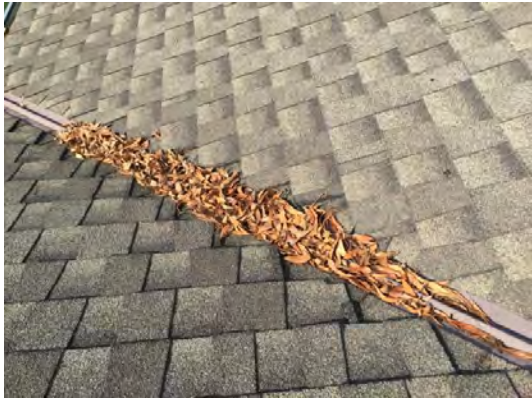
*Photo 7*

**Debris - Leafs and Pine Needles:** Pine needles and other leaves build up on the roof membrane causing plugged drains and scuppers thereby causing ponding water and structural weight loading. As the leaves and pine needles rot a "compost effect" occurs, this in effect causes soil to form on top of the roof membrane. This soil creates a perfect medium for plant and weed growth. When seeds take hold the roots will often penetrate through the membrane causing immediate leaks and damage internally.

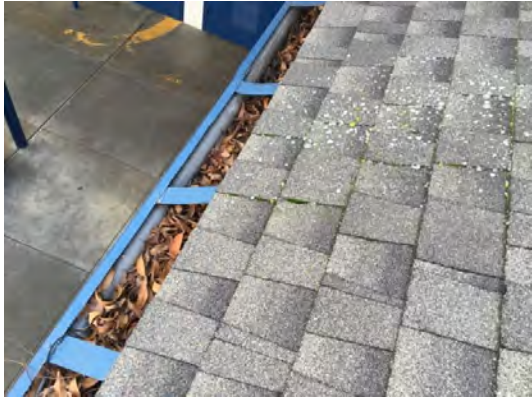
*Photo 8*

<b>Rating</b>	Fair
<b>Condition</b>	Leaves and debris have filled some gutter sections. The gutters should be cleared to prevent the drains from clogging.

Gutter full of leaves and debris.

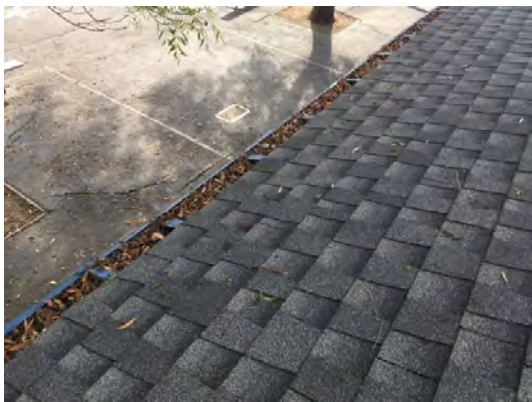
*Photo 9*

Leaves and debris will cause the downspouts to clog increasing the weight load in the gutter.

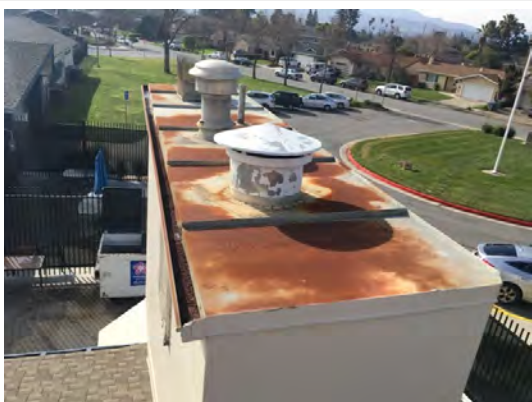
*Photo 10*

<b>Rating</b>	Good
<b>Condition</b>	The roof penetrations are in good condition. However the chimney cap is rusted and decaying. A new replacement cap or restoration coating is recommend.

Rust corrosion on chimney cap will continue to spread. The rust should be treated with a rust prohibitive primer and coated with a protective urethane to avoid further decay.

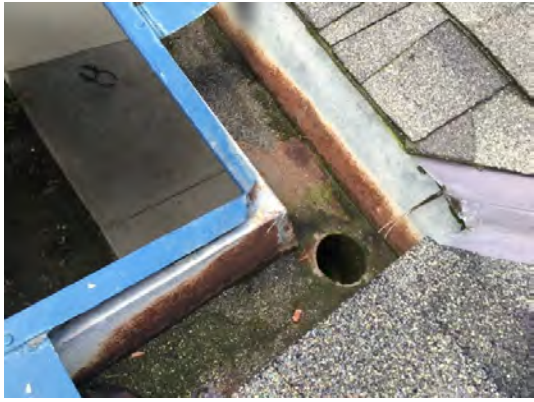
*Photo 11*

<b>Rating</b>	Good
<b>Condition</b>	The roofs perimeter is in good condition. Rusted gutters should be monitored and restored to prevent further decay.

Rust corrosion in gutter will continue to spread.
